CONDENSATION AND INDOOR AIR QUALITY PROBLEMS AS A RESULT OF HIGH PERFORMANCE BUILDING ENCLOSURES - THE NEED FOR INTEGRATED DESIGN AND A NEW INVESTIGATION PROTOCOL

Brian Hubbs, P.Eng.
Robert Orłowski, ASCT
Graham Finch, P.Eng
RDH Building Engineering Limited

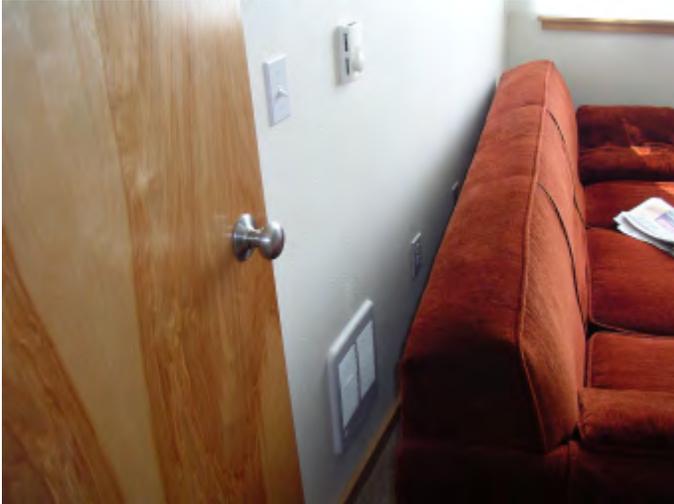
occupant thermal comfort and increase the likelihood of condensation related issues at the exterior walls and windows. See Figure 1.

- › In several instances furniture was located in front of cadet heaters, lowering their effectiveness and/or creating a fire risk. See Figure 1.

Figure 1
Electric cadet wall heater located behind couch, away from exterior wall and directly below thermostat leading to poor temperature control within the room.

- › **Locate heating either at the exterior walls** or so that heat is directed to and reaches the exterior walls. Baseboard heating is preferable to cadet heaters for this purpose. This is particularly important when designing small living spaces since wall space for shelving and storage is at a premium. Heaters that are located on opaque wall areas will reduce this space and will likely be modified or covered over by some occupants in order to meet their space needs.

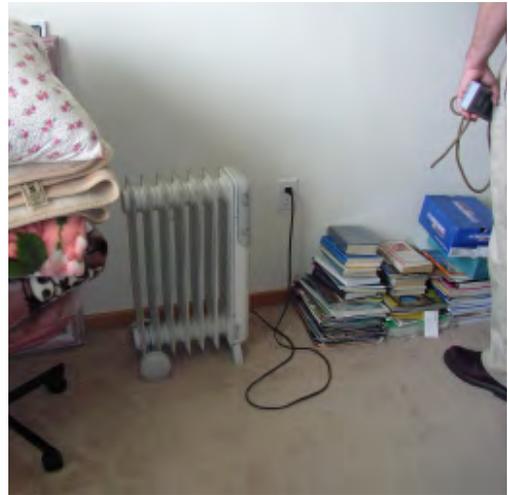
- In some suites the electric heating systems are not used by the occupants, as they are perceived to be expensive. Occupants also complain that the cadet heaters (electric fan coils) are noisy. At some buildings, plug in style oil filled radiators are used in lieu of the electric baseboard or cadet heaters. See Figure 2.
- In many instances, the electric cadets are located towards the unit interior rather than at or near an exterior wall. Also, interior located heat sources are often situated directly beneath thermostats. In some suites the occupants reported feeling cold even when the heaters were used. Since heat was not being provided at the exterior walls, the relatively cold walls reduce

Figure 2
Use of oil filled radiators in same room as shown in Figure 1.

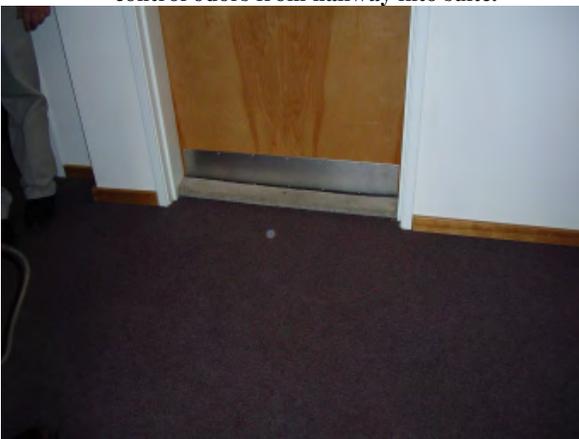
- › Little to no gap beneath hallway doors to allow make-up air to flow to units (supply from corridor). Little gap at base of bathroom door, suffocates continuous bath fan (suite layout, such that bathroom door remains closed the majority of the time).
- › Closures are installed at base of hallway doors to stop draft and odors from under the door and hence cut off “fresh” air supply. See Figure 3.
- › Trickle vents in windows are closed.
- › In some corridor buildings, stairwell doors are propped open raising the question of building pressures, mechanical system balancing, Continuous exhaust – where is make up really being drawn from in corridor buildings. See Figure 4.
- › Draft under door in corridor buildings
- › Complaints of odors from suite occupants in many buildings

Figure 3
Undercut door intentionally blocked to resist drafts and control odors from hallway into suite.

- The suites should be compartmentalized with an air-tight perimeter maintained between the suite and the corridor and between adjacent suites. This recommendation addresses many of the air flow control issues that were identified in the field survey.
- Space layout should be designed to encourage locating large pieces of furniture away from exterior walls and windows.
- Poorly ventilated spaces such as closets should not be located on outside walls.
- Windows should be located towards the interior portion of wall assemblies to encourage 'washing' of the window with interior heated air. This maintains warmer temperatures at the surface of the window assembly. This window placement is also better from a water penetration control perspective since the windows are somewhat protected when recessed.

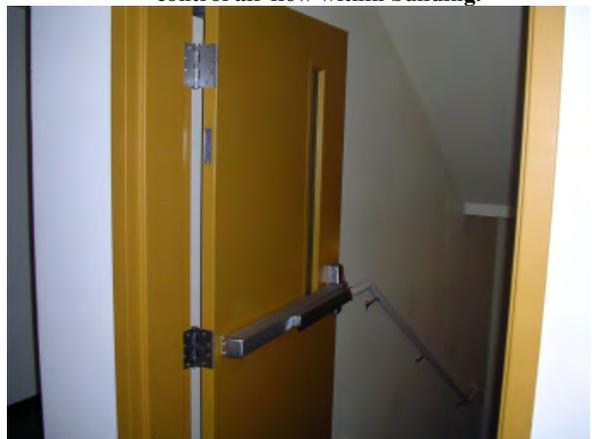
Figure 4
Stairwell doors propped open frustrating attempts to control air flow within building.

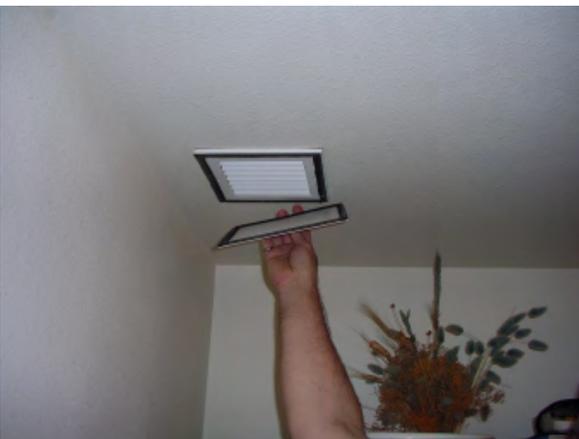
- › Manual operating point source exhaust fans are not used in kitchens and baths.
- › Fans are disconnected if they are noisy, or alternately when they become noisy rather than replacing or maintaining them.
- › Exhaust grills fitted with covers by occupants to shut-off flow do to perception of heat loss from exhaust system. See Figure 5.
- › Exhaust ducts terminated within attic spaces ‘close’ to the exterior. See Figure 6.

Figure 5
Cover to close exhaust grill.

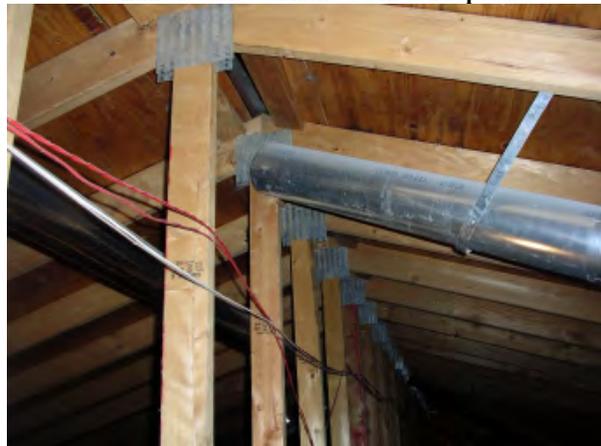
Figure 6
Exhaust duct terminated in attic space.

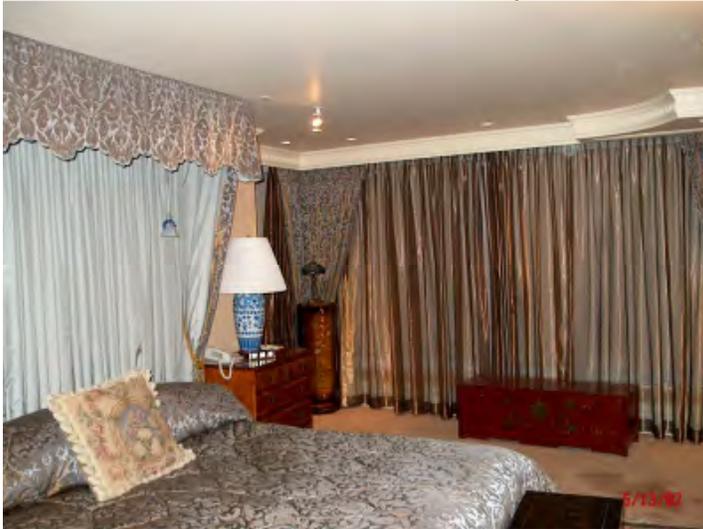
Figure 7

Curtains prevent air from circulating at exterior wall and window-wall. Conditioned air is being directed to the outside walls from an interior location almost 7m away.

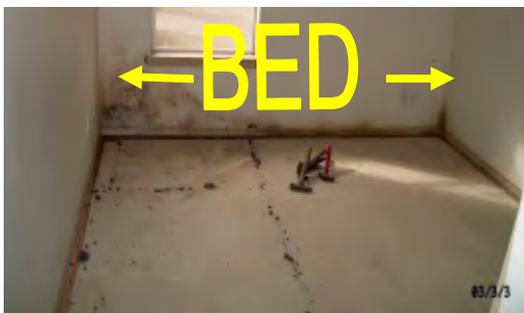
Significant levels of mould and deterioration were observed within a vinyl clad townhouse complex in Washington State [2]. The damage occurred along the base of the walls both at the exterior sheathing and on the interior surface of the interior gypsum sheathing. The investigation of the cause of the moisture problems identified issues related to exterior water penetration as the cause of deterioration of the sheathing. However, the high levels of mould and deterioration on the interior gypsum board (Figure 8) could not be explained by exterior moisture sources alone. In many cases all of the visible mould was located on the interior of the polyethylene vapour retarder while insulation and framing to the exterior of the polyethylene was observed to be in good condition (Figure 9).

Figure 8
Mould on Interior Surface of Exterior Wall in Bedroom

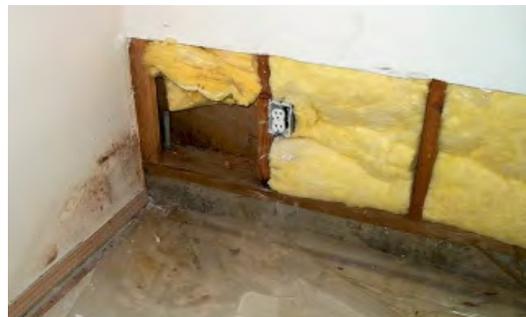
Figure 9
Insulation and Studs in Good Condition on Exterior of Vapour Barrier

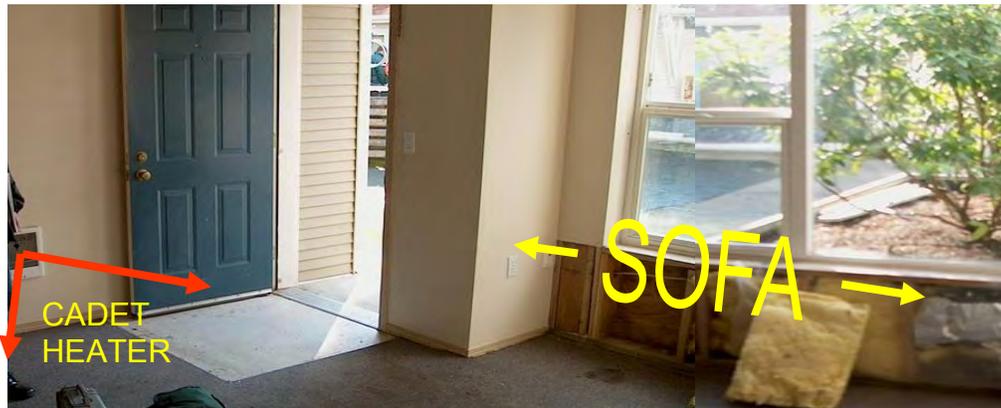
- › Electric cadet heaters and thermostat controls were located a significant distance from the exterior walls and were often not directed at the exterior walls (Figure 10).

- The interior space layout dictated that many of the obvious locations for large furniture such as beds and couches are adjacent to exterior walls. The location of large furniture in these areas had the dual effect of adding insulation to the interior of the wall and blocking heat flow from the cadet heaters (Figures 8 and 10).
- Units were constructed over an unheated parkade and the interior floor consisted of a structural concrete slab covered with polystyrene insulation, gypcrete and carpet. The detail at the base of the exterior walls incorporated a perimeter concrete curb that was attached to the suspended structural slab, creating a thermal bridge through the insulation in the sandwich slab (Figure 11).
- Humidity in many of the units was higher than expected, and clothing and other personal affects were found piled up against the exterior walls in a number of units.

Figure 10
Location/Orientation of Cadet Heater, Furniture and Resultant Mould

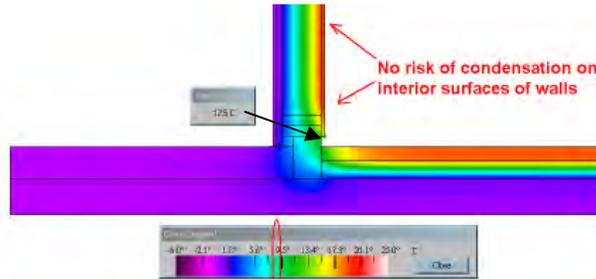
A simulation of the base of wall detail was performed using Therm 5.2 [3] to better understand the contribution of the thermal bridging to the condensation and mold problem. The model utilized an exterior temperature of 0°C and an interior temperature of 20°C. At this temperature and an interior relative humidity of 50% the dew point of the air is 9°C. The simulation in Figure 12 models the wall interface without interior furniture. The coldest interior temperature is 12.5°C indicating that the risk of condensation would be quite low under the modeled conditions. When the same detail was modeled with a sofa on the interior of the wall in Figure 13, the results show surface temperatures of 6.7 °C, which is significantly below the dew point of the modeled conditions. The temperature region between 6.7°C and 9°C (dewpoint), shown on Figure 12 is approximately the same location where interior mould was observed on the walls during the investigation.

Figure 12
Temperature Isotherm At Base of Wall

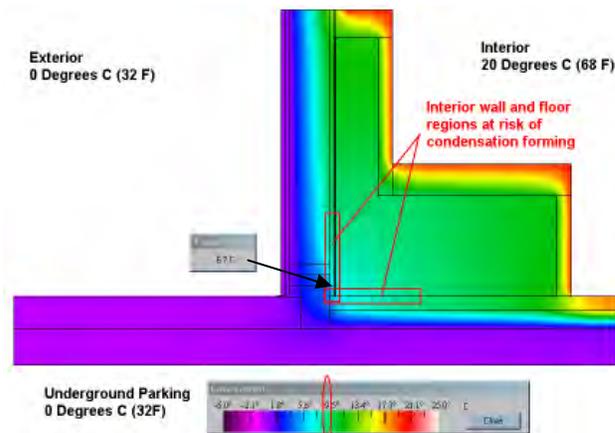
Figure 13
Temperature Isotherm At Base of Wall With Sofa
Adjacent to Interior Surface

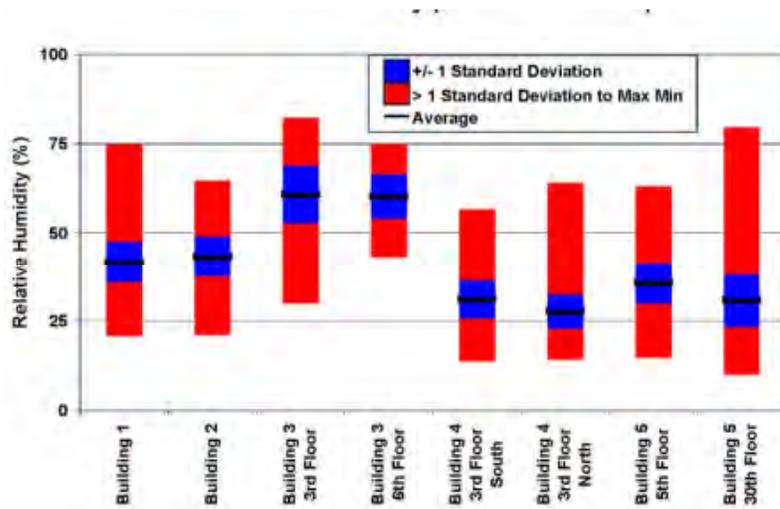
Figure 14
Interior relative humidity (winter 2003/2004)

values exceeding the commonly used design RH of 50% during the winter months. The interior RH measured for Building 3 is much higher than traditional expectations for winter RH. With an average RH of 61% and a standard deviation of 7% it would not be uncommon to find RH levels exceeding 68%. The consistency of the results between different units in the same buildings may also indicate that RH is impacted more by the interaction of the building envelope and HVAC system than the occupancy of the suite.

The highest RH levels were observed in Building 3. Building 3 is a mid-rise building that was originally clad with a face seal stucco wall assembly and aluminium window assemblies. Building 3 had been experiencing water infiltration problems and high humidity levels since construction. Traditionally these wall and window assemblies have allowed relatively high levels of air leakage both through and around the assemblies. As a result, mechanical designers were able to assume that a significant portion of the overall ventilation requirement would be taken up by air leakage through the wall and window assemblies. When the building was rehabilitated to reduce water infiltration and repair damage to underlying wall components, the conventional sheathing paper was replaced with a continuous self-adhesive modified bituminous air and moisture barrier membrane. In addition, the existing windows were replaced with higher performance windows. The resulting exterior building envelope was much more watertight and airtight than the original construction. The expected result of the recladding would be that the reduction in water infiltration would result in lower moisture levels and in turn humidity levels in the building after the work was completed. The continued high humidity levels observed post remediation are at least partially a result of the increased air tightness of the wall assembly invalidating the original mechanical assumptions regarding air leakage through the exterior walls. Occupant lifestyle and building HVAC systems are also likely playing a significant role in the abnormally high interior RH levels observed after the rehabilitation.

Figure 14 shows the interior RH values for all five monitored buildings during the winter of 2003/2004. The interior relative humidity in all five buildings exceeds 50% for some period of time during winter months. Readings on Buildings 4 and 5 are indicative of common assumptions with regards to interior relative humidity with an average winter RH of 32% and a standard deviation of 6%. Buildings 1 and 2 have elevated RH levels with the average being 43% and a standard deviation of 6%, meaning that it would not be unusual to experience interior RH
