Re-Glazing of All Glass Curtain Wall Buildings

ABSTRACT

1.1 Background

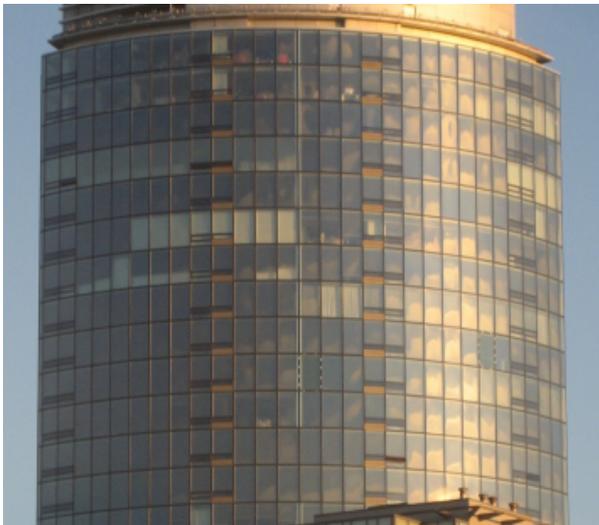
Fogging inside a high percentage of the IGUs was first observed in 2003, though only the clear glass on the upper floors made the fogging highly visible to the occupants. Several initial attempts were made by the contractor to fix the problem but without success. Within a few years the condensation moisture led to corrosion of the surface #2 silver low-e coating within the IGUs of the condominium floors. Our firm was retained in 2006 by the owners to investigate the IGU failure. The investigation was completed between 2006 and 2009.

Figure 1: Widespread fogging within each IGU visible on the building elevation from the street.

The findings of the investigation and the ongoing fogging and thermal discomfort prompted the owners to seek a replacement of all the glass on the residential floors. The IGUs on the hotel floors using a darker tint and stainless steel low-e coating did not experience the same level of corrosion, and the hotel was not prepared to undergo the extensive work required.

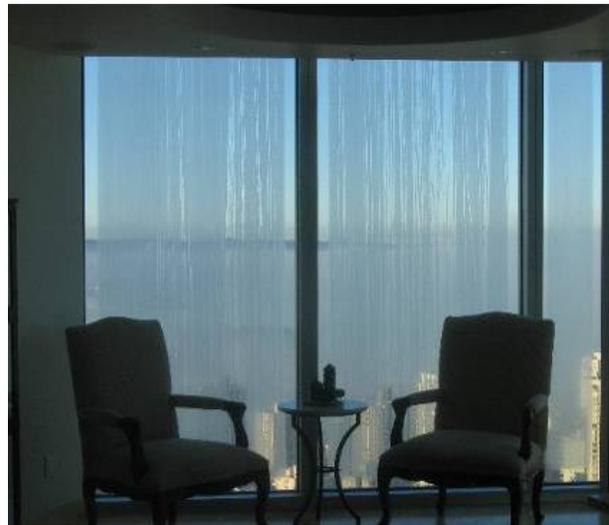
Figure 2: Fogging and corrosion of the low-e coating due to condensation within the IGU.

The investigation determined that the primary failure mechanism causing fogging and low-e corrosion was a poorly designed and constructed proprietary IGU edge spacer. The edge spacer design, shown in Figure 4, used a combination of aluminium, PVC, stainless steel foil, and hot-melt butyl to create a more thermally efficient edge spacer. However, the combination of materials and different coefficients of thermal expansion/contraction led to premature failure of the edge seal at numerous points. In addition, the replaceable desiccant tube design led to increased air and moisture flow into the IGU, which contributed to the failure.

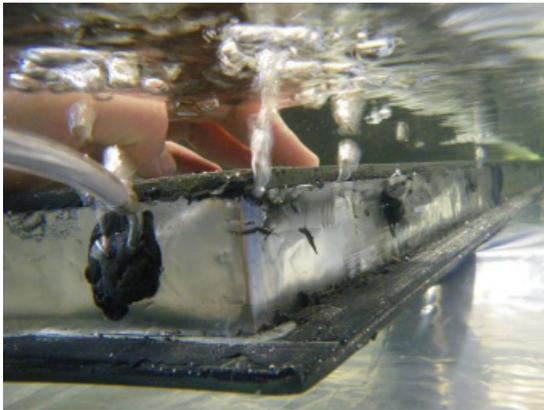
- IGU pressure testing and flow testing to measure leakage rate of IGUs and flow through desiccant tubes, and
- Submersion testing of removed IGU to visually review leakage points (Figure 3)

Figure 3: Submerged IGU with airflow from discontinuities in the edge seal.

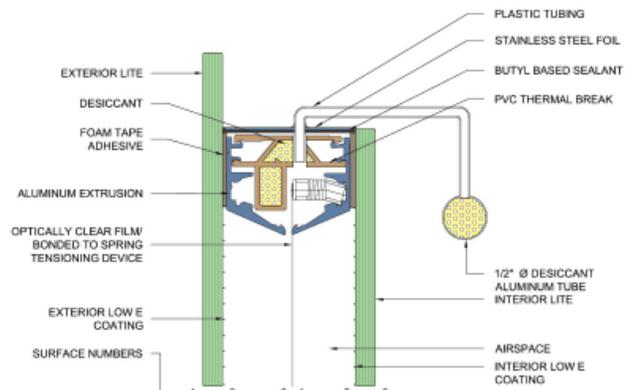
Figure 4: Proprietary thermally efficient edge spacer design.

Ultimately an anodized aluminium edge spacer was used with a polyisobutylene primary seal and silicone secondary seal at each air space. Argon fill was used to further increase the thermal performance of the replacement IGUs.

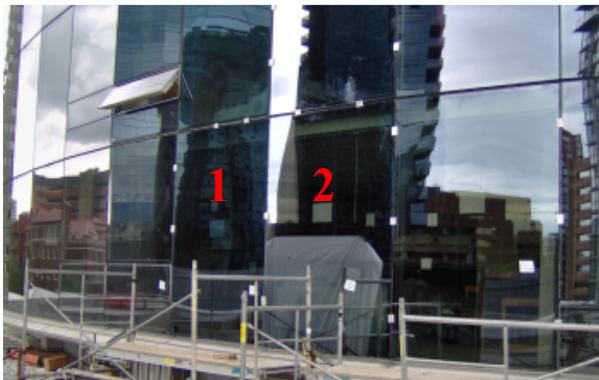
Once the IGU selection was narrowed down, several full size triple glazed mock-ups were ordered and installed on the building at the lower hotel floors (see Figure 5). This process was important to be able to view the proposed replacement IGUs directly next to the existing hotel glazing in different lighting conditions. This step proved to be useful in further narrowing the selection, and discovering significantly mismatched colours prior to the full scale manufacturing (see Figure 6). The final colour was selected on-site from the full-scale mock-ups.

Figure 5 : Five full scale mock-ups installed at the lower hotel floors for colour comparison.

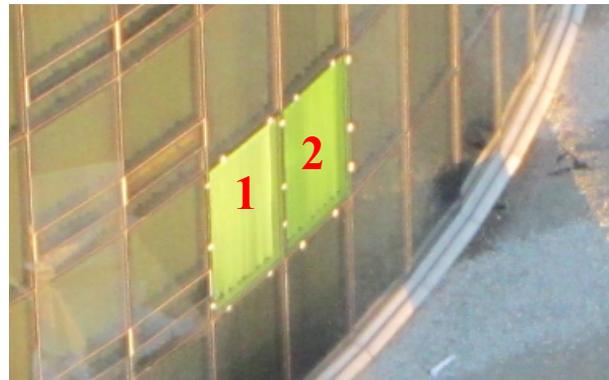
Figure 6: Significantly mismatched colour samples made visible in indirect sunlight on the building face.

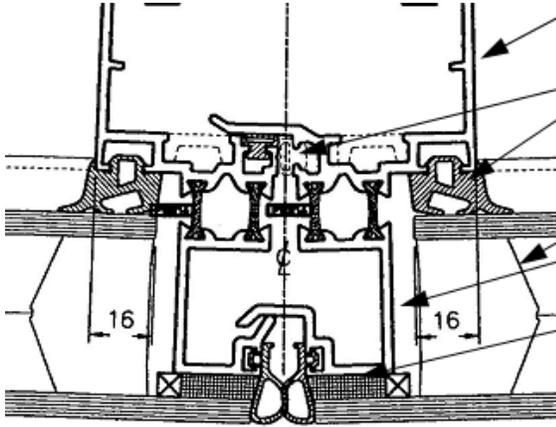
The building uses a unique aluminium frame curtain wall system, shown in Figure 7, where the IGUs are adhered to the frame using structural silicone on the offset edge of the exterior most lite. The SSG curtain wall achieves an architecturally appealing look with no extruding mullions or snap caps. The original IGU installation work was completed at the factory and the curtain wall frame was then installed on the building. This SSG system presented a difficult challenge with respect to glazing replacement work. The curtain wall frame could not be removed from the building, so the replacement work had to be completed in the field. This work has to meet factory quality control standards and meet the same air leakage and water penetration control performance standards as the factory installed SSG system. In addition, the design of the curtain wall frame only allowed glazing replacement work from the exterior of the building. This means that the replacement work had to consist of:

Figure 7 : Existing SSG curtain wall mullion configuration.

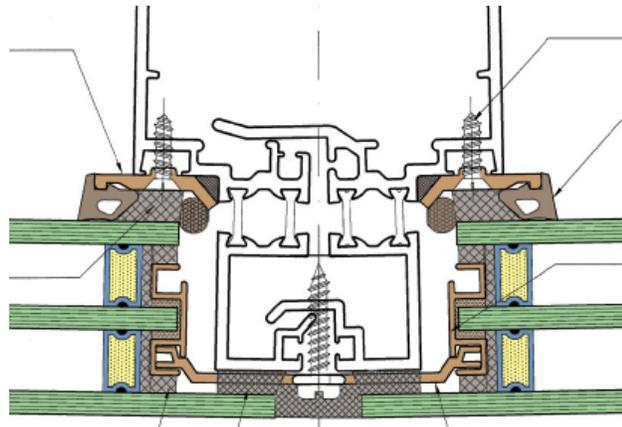
Figure 8: Initial conceptual clip design system.

These challenges prompted our firm to design a replacement plan that does not require any exterior bracing to hold the IGU in place while the silicone cures, in order to avoid having to revisit the installed IGUs to complete the sealant work. As a result, a proprietary clip rail system was designed that allowed the replacement IGUs to be secured in place from the interior and provide a structural attachment while the silicone cures. An initial design, shown in Figure 8, was completed by our firm to show the intent. The system had to both structurally secure the

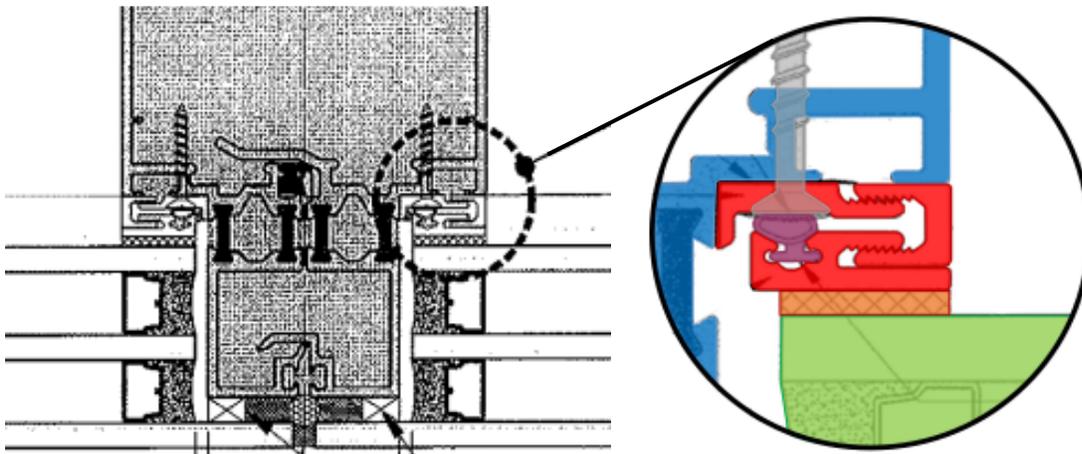
Figure 9 : Continuous clip and gripping cover clamp system (red) complete with gasket (purple) adhered to the glazing with structural tape (orange).

The final design and manufacture of the clip rail system was completed by the glazing company awarded the replacement work, with the assistance of the glazing structural engineering consultant and our firm. The design uses continuous aluminium clips and a gripping cover clamp around the interior perimeter of each IGU, with an interior gasket to provide the air and moisture seal (see Figure 9). The clip system is designed to provide a long term temporary structural attachment capable of withstanding high wind loads on the 48 storey building. This was intended to allow for the primary silicone structural attachment to be installed and fully cure before taking any loading.

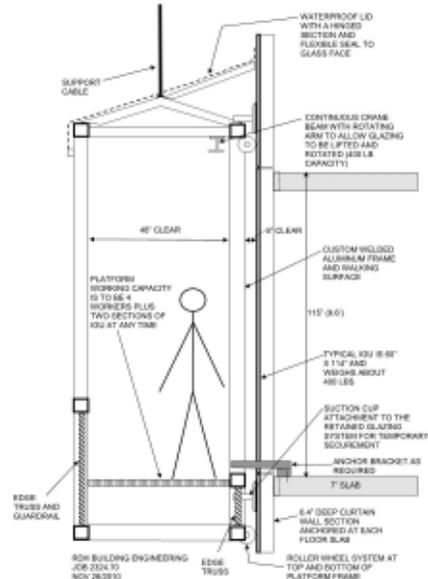
Figure 10 : Conceptual design for suspended scaffolding platform.

For these reasons, the use of a custom built suspended scaffolding ring was needed. It needed to be hung from the roof around the perimeter of the building, large enough to allow for work at one full height floor from one position, and built with the structural capacity to support two full work crews and multiple IGUs at once.

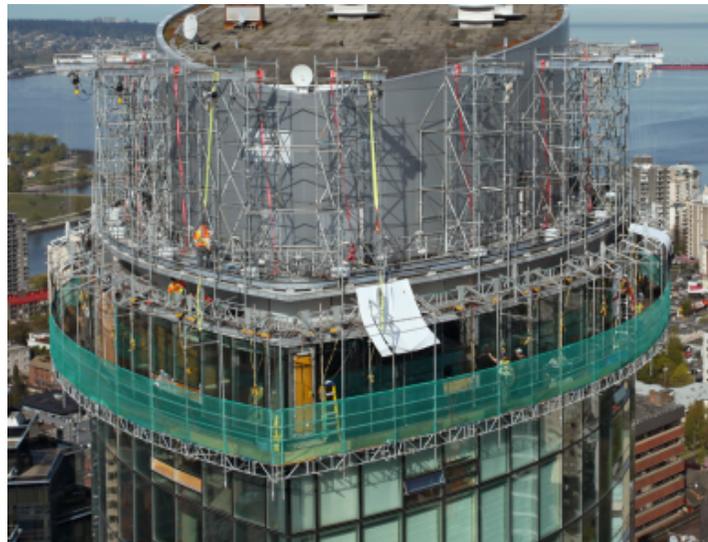
Figure 11: Installed suspended scaffolding and hoist towers

One unique challenge discovered during the replacement work was that the scaffolding framing was positioned too close the building face. Foam padding was installed around each post adjacent to the building, and adjustments were made to the framing to make room for IGU replacement.

The full height suspended scaffolding ring platform was designed and built based on the initial conceptual idea. Eighteen hoist towers with computer controlled motors installed around the roof perimeter controlled the platform. The platform was constructed to fit closely to the building face. Flexible sheathing was placed between the platform and the building face to avoid dropping any building materials or tools. The design and construction of the suspended scaffolding platform was completed with extensive load testing and review from third party structural engineering consultants and insurance providers. The platform also included a hoist system on a continuous rail so that IGUs once on the platform deck could be lifted and positioned in place. The hoist motors used a specialized suction cup mechanism to attach the hoist cables to the IGUs. The platform was secured into the building structure using intermittent tie-back anchors attached into the structural concrete. The final result was a remarkably stable work platform that allowed for detailed work at all parts of the curtain wall at each floor.

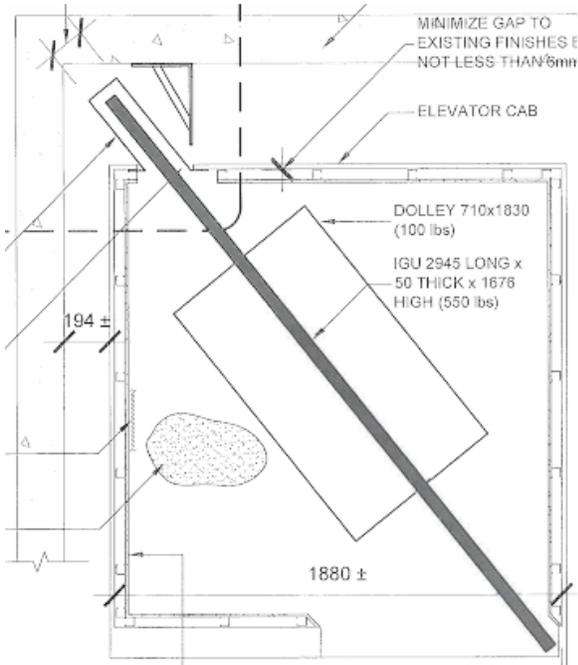
Figure 12 : Corner notch design in the residential elevator.

The full size IGUs measure 48 inches wide by 114 inches tall. Since lifting the IGUs on the exterior of the building was not a viable option, modifications were made to one of the two residential access elevators in order to fit the IGUs in horizontally one at a time. A notch framed into the corner of the high speed cable driven elevator, shown in Figure 12 and Figure 13,

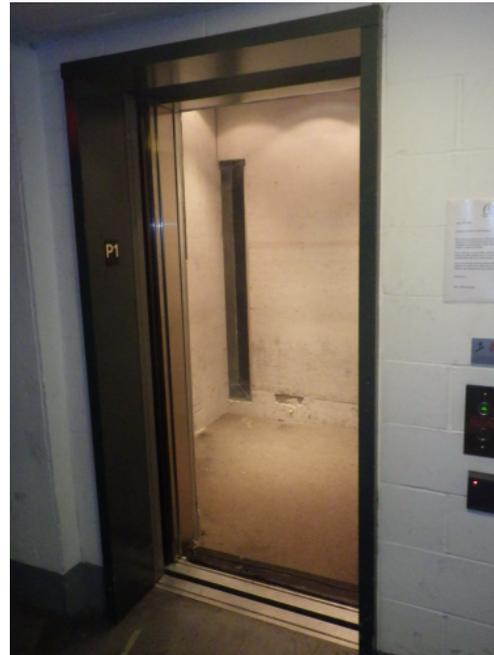
Figure 13: Completed steel notch and protection board within the elevator to protect finishes.

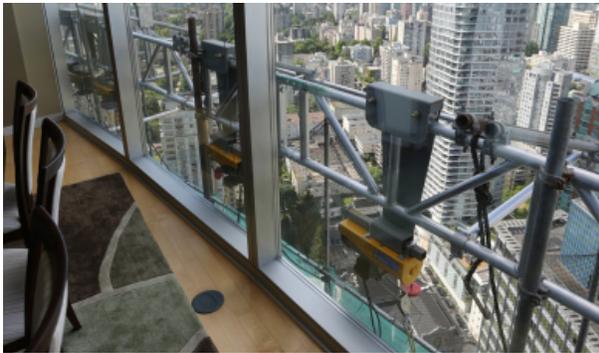
Figure 14 : IGU hoist motors mounted on the suspended scaffolding rail.

The IGUs were cut out from the exterior using speciality sealant cutting knives. Each IGU was anchored to the hoist system and lowered onto the custom aluminium carts. The carts were then wheeled off the platform and through the designated access suite and down to the ground level through the elevator. Meanwhile, the window opening was prepared by removing the remaining existing sealant, and installing the clip rail system. The clip installation was the most important step to achieve a correct IGU fit and interior seal. The clips had to be aligned to match with the incoming IGU clips, and receive the gripping cover clamp. The new IGUs were wheeled to the window opening and hoisted in place. Silicone pad shims were used to position the IGU, and the gripping cover clamp was snapped in place.

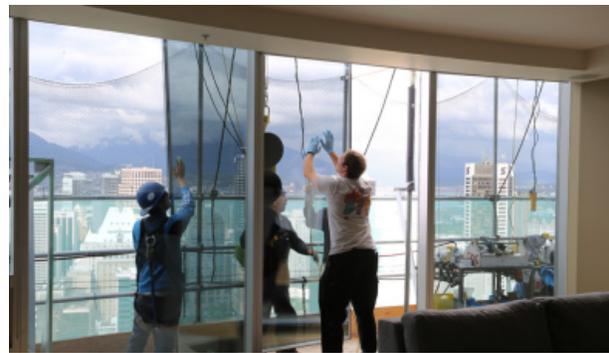
Figure 15: The IGU is positioned in the window opening.

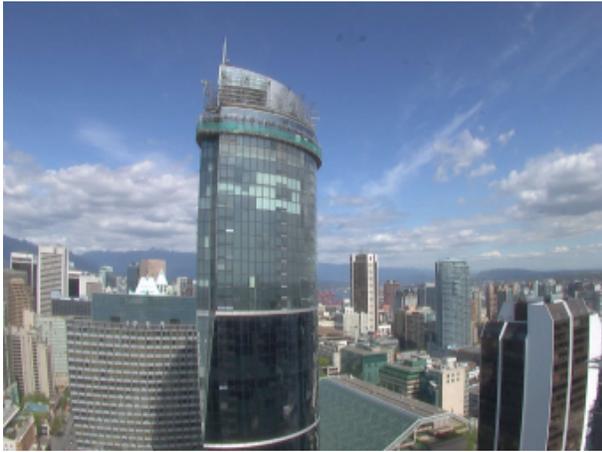
Figure 16: Project building with one floor of IGU replacement complete

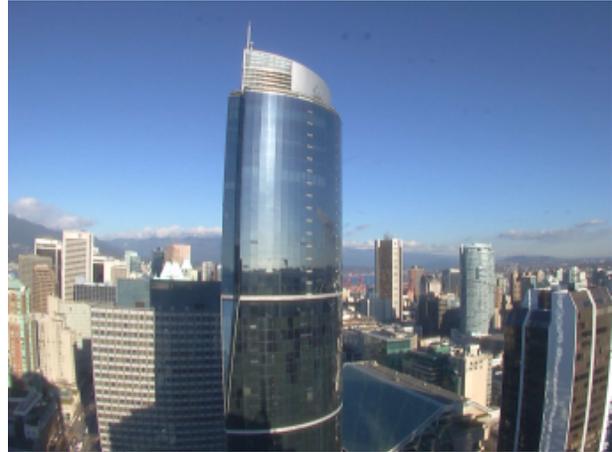
Figure 17: Project building with complete IGU replacement.

The new IGUs on the residential floors achieved the intended results. The replacement work was completed over the 2013 summer season and the building now has new glass on the upper 17 floors that closely matches the lower existing hotel glass. The suite occupants no longer experience excessive solar heat gain, and the windows can be seen through clearly.
