# Conservation and Restoration of the Spencer Building in Vancouver, British Columbia

By Marcus Dell, PEng and Michael Grummett, PEng

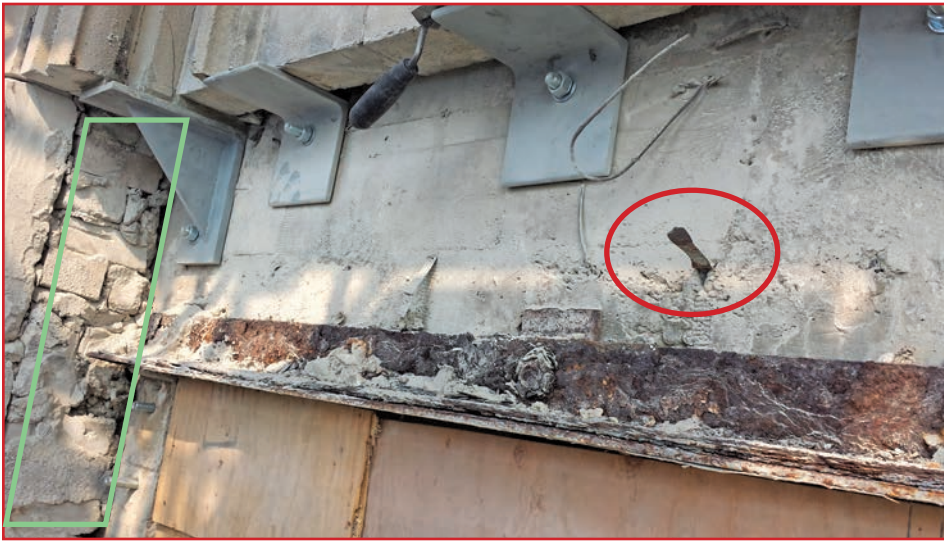
*Figure 2 – Severely deteriorated shelf angle. The red circle illustrates one of the original masonry ties used to secure the cast stone to the concrete frame. The green rectangle illustrates the typical masonry rubble installed between the cast stone and the concrete frame. The plywood was used to protect the window during removal of the masonry.*

In short, the primary cause of the deterioration at the Spencer Building was corrosion of steel components. The corrosion of the shelf angles (Figure 2) resulted in large vertical compressive loads within the brick and cast stone because the façade did not include any control joints. These large vertical loads in conjunction with lateral loads (outwards) caused by corrosion of the window frames resulted in overall instability of the masonry cladding and spalling of the brick and cast stone (Figure 3). In some

Given the owner's request for a 50-year design service life, and the desire to provide a uniform support condition throughout the building exterior, it was decided that all the shelf angles would be replaced with new hot-dipped, galvanized shelf angles. Consideration was given to the use of stainless steel shelf angles, but the cost increase was deemed excessive. The new shelf angles were attached to the building frame using stainless steel threaded anchors set into epoxy resin (*Figure 8*).

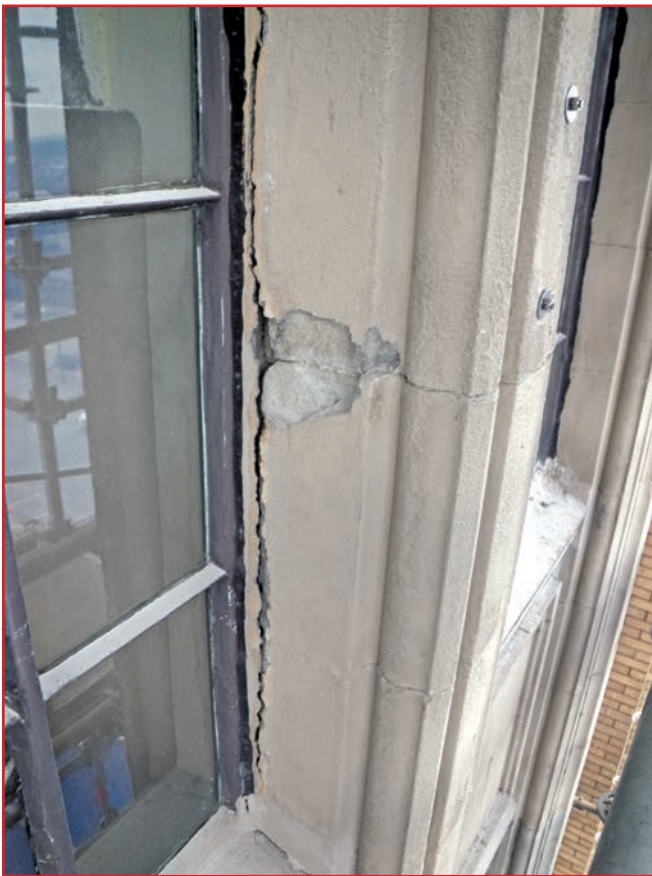
*Figure 3 – Damaged cast stone due to corrosion of window frame and significant vertical compressive loads created by corrosion of the shelf angles at the floor levels.*

locations, the cast stone at the window jambs was bowed outward up to 12.5 mm (½ in.) between floor levels. The outward bowing and the significant compressive loads had crushed the inside edge of the cast stone.

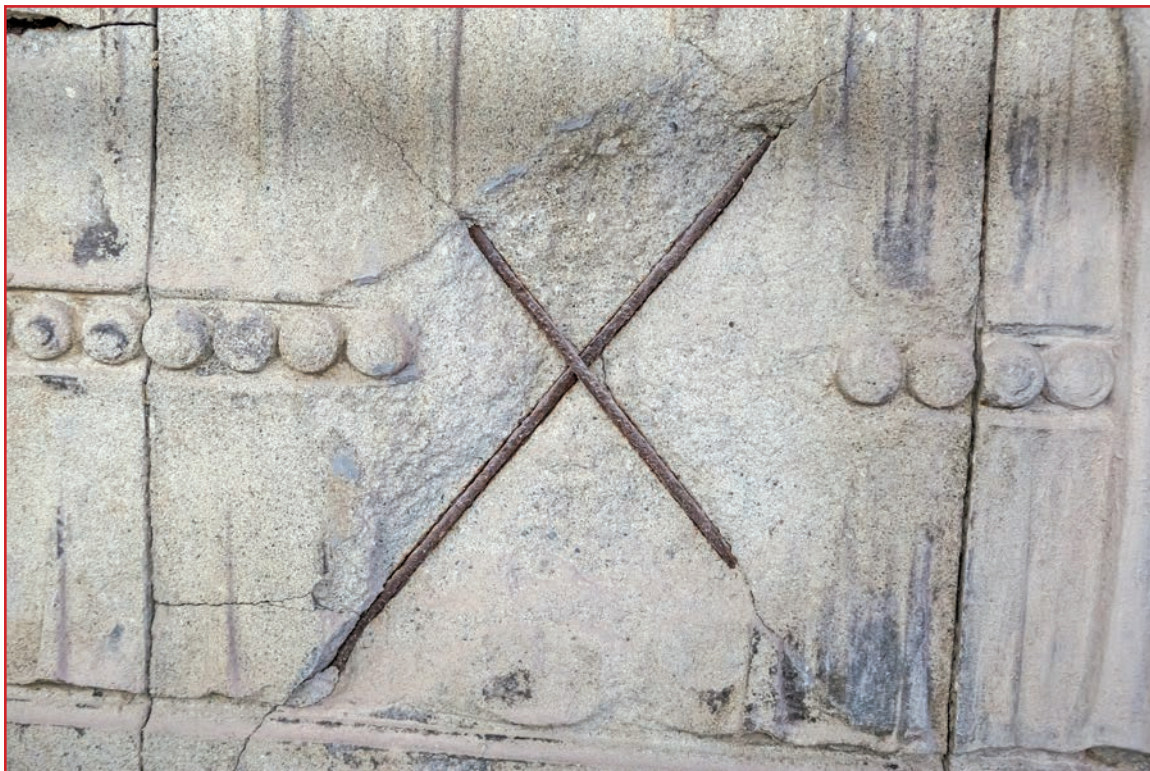
*Figure 4 – Damaged cast stone due to corrosion of embedded reinforcing steel.*

In addition, expansive forces caused by the corrosion of the steel within the cast stone damaged the cast stone units themselves (*Figure 4*).

Reinforcing was added to each cast stone unit to improve the structural integrity of each unit during installation and in situ. The reinforcing bars used are 304 stainless steel to reduce the risk of corrosion and resultant damage to the cast stone units. Care must be taken to ensure that blades used to cut the stainless steel during manufacturing were purpose-specific, and that they had not previously been used to cut conventional carbon steel (cross contamination can result in corrosion of the stainless steel). Attempts were made to have a minimum of 1½ in. of concrete coverage over the stainless steel reinforcing bars; however, this limit was sometimes reduced due to the need for field "trimming" for installation purposes. The decision to use stainless steel reinforcing was reinforced (pun intended) by the difficulty of ensuring the minimum concrete coverage.

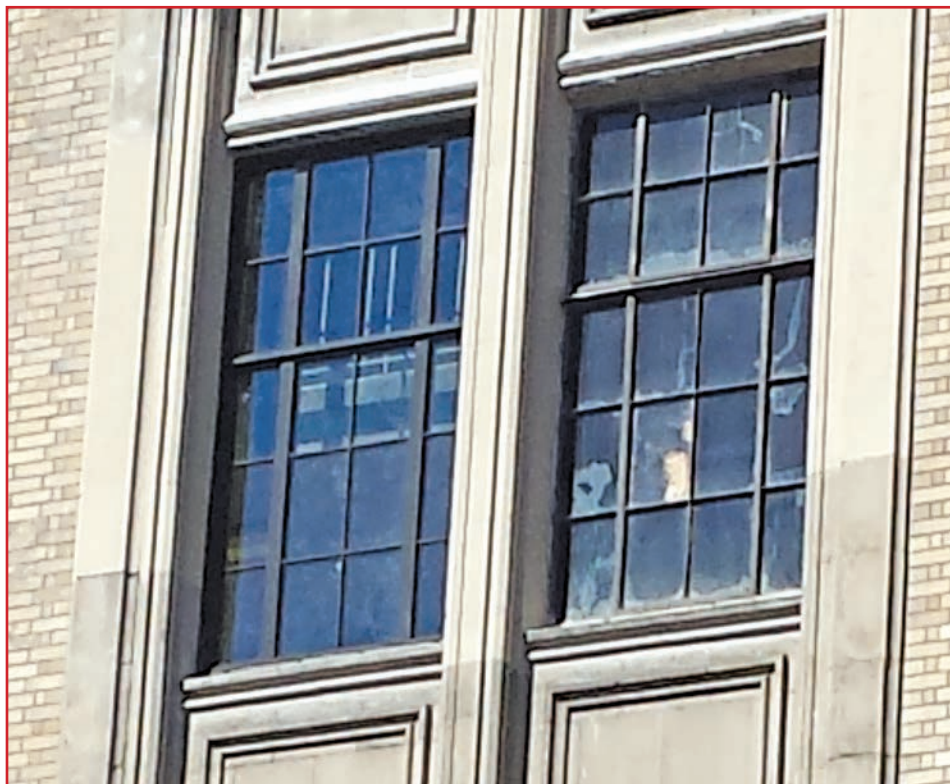
*Figure 5 – Photograph of a new window on the left and an original window on the right.*

to develop a thermally broken window configuration that closely resembled the originals. Muntin bars were placed within the insulating glass units (IGUs), and additional muntin bars were adhered with double-sided tape to the exterior of the IGUs (mechanically fixed at perimeters), resulting in an acceptable aesthetic. Care was taken to ensure that the new muntin bars had the same dimensions (width and projection) as the originals. *Figure 5* illustrates an original and a new window adjacent to each other. During the installation, a continuous moisture and air seal was installed between the concrete frame of the building and the new

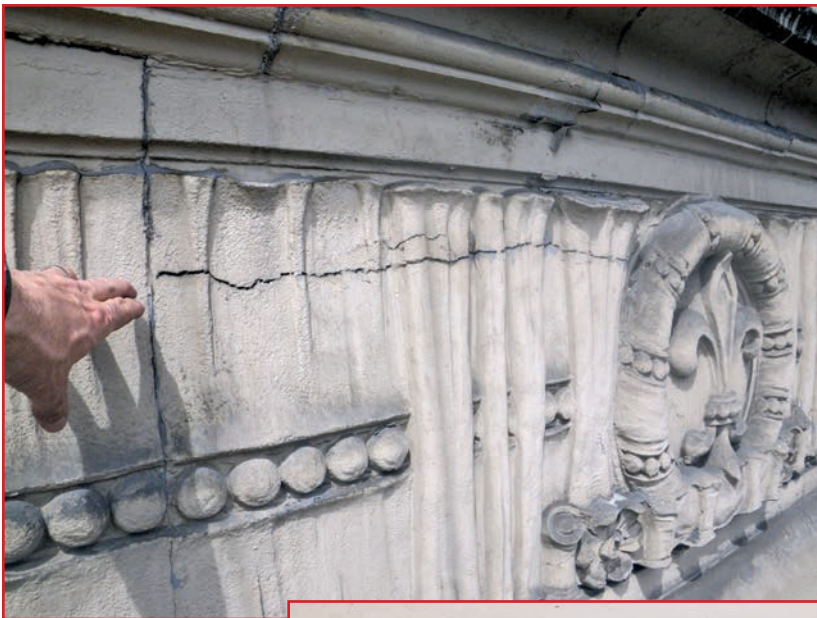
*Figure 6A – Condition of cast stone at time of condition assessment.*

Figures 6A and 6B illustrate a sample of cast stone at the time of original review, and a similar piece after completion of the restoration and conservation. The significant color difference is due primarily to the

accumulation of atmospheric dirt on the original uncleaned stone.

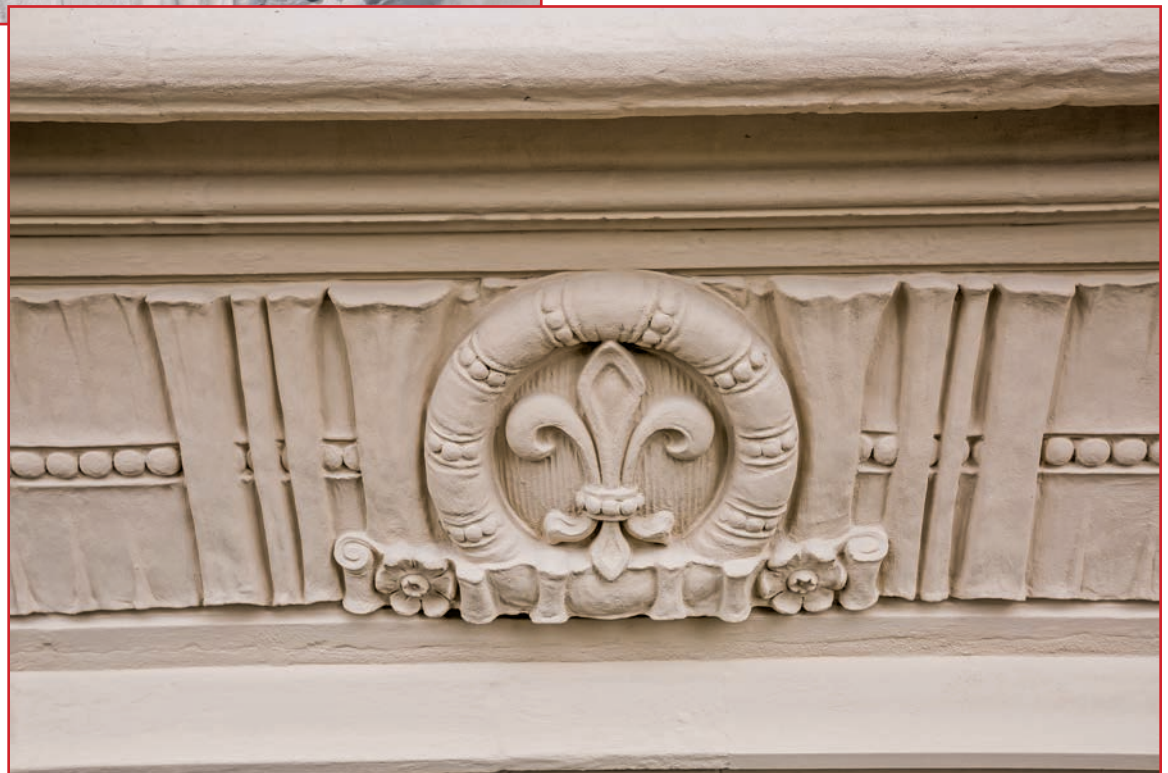
*Figure 6B – Condition of cast stone after restoration.*

The mineral silicate coating was applied in a three-step process. One of the steps in the process included the application of a "fine filler," which helped hide some of the surface imperfections in the original cast stone that was kept in place.

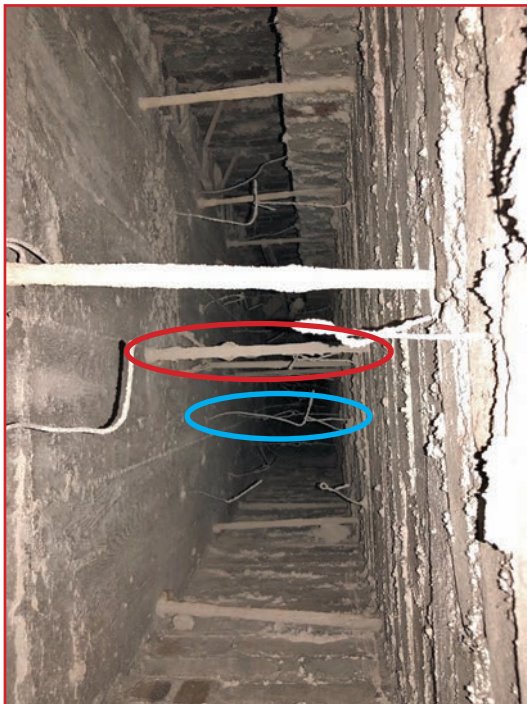
Figure 7 – View down into the cavity between the back of cast stone units and the concrete backup. Clearly visible are the sieves filled with epoxy resin and stainless steel threaded rods (red ellipse). Also visible are the wire ties installed at the time of original construction (blue ellipse).

the rods penetrated all the way through any rubble or voids that were present behind the cast stone. *Figure 7* is a view into a cavity behind a section of cast stone.

reduce the potential for lateral movement. Stainless steel rods, sieves (sometimes called screens), and epoxy resin were used for this purpose. The length of the rods had to be carefully determined to ensure that

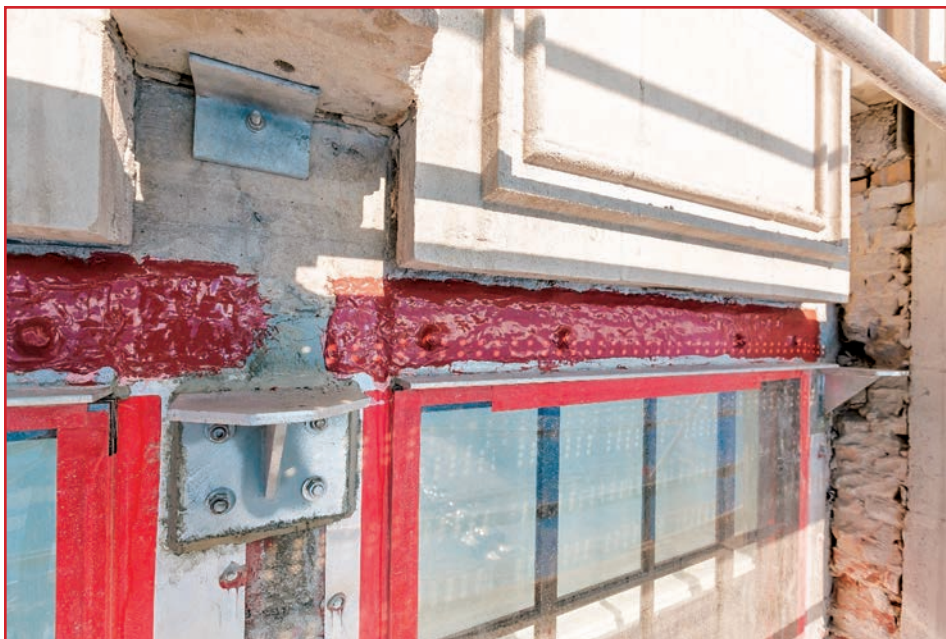
*Figure 8 – Shelf angles attached to primary frame with anchors set into epoxy resin. Liquid-applied membrane used between shelf angle and concrete back frame.*

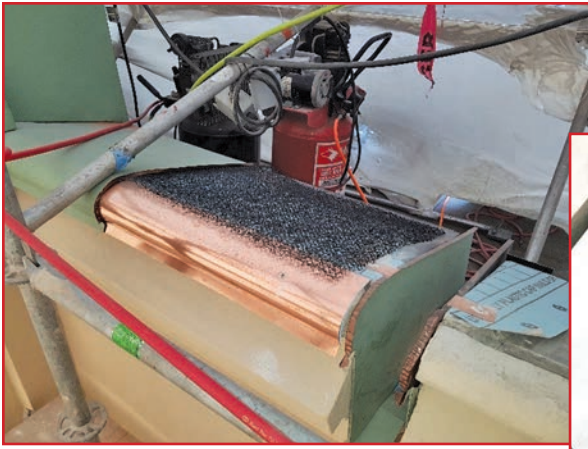
Figure 9A – Pre-patinated copper flashing installation on parapet walls. The wind clip is formed from new copper, and drain mat is installed below the cap flashing to facilitate drainage.

Gradually, the risk of staining decreases as the copper weathers. Therefore, pre-patinated (green-color) copper flashings were used (Figures 9A and 9B). A vapor-open drape membrane and a drainage mat were used between the flashings and cast stone parapet blocks to facilitate drying of the cast stone.

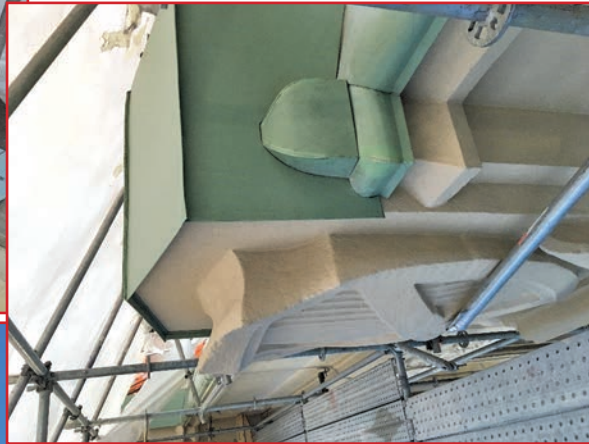
Figure 9B – Pre-patinated copper flashing installation on parapet walls.

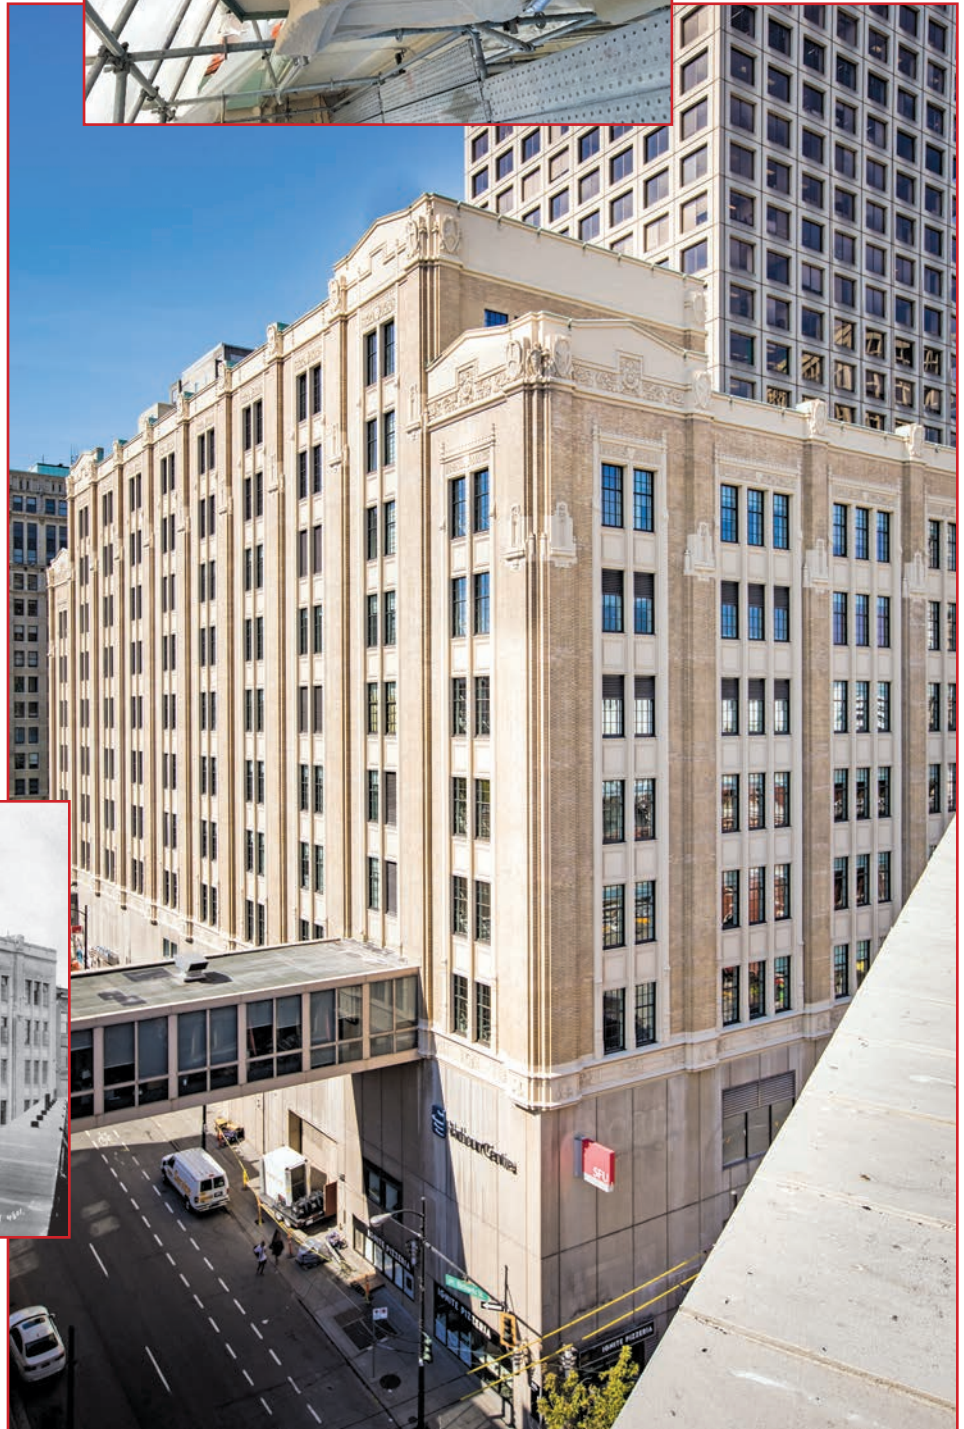
Figure 10B – Spencer Building in 2018 after conservation and restoration.
