In-Slab Duct Research & Monitoring

Acknowledgements

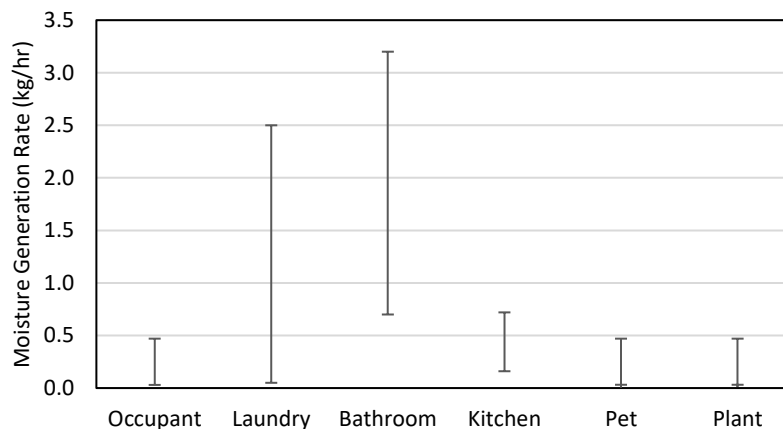
Figure 1.3: Relative moisture generation rate by source (kg/hr), when operating or present.

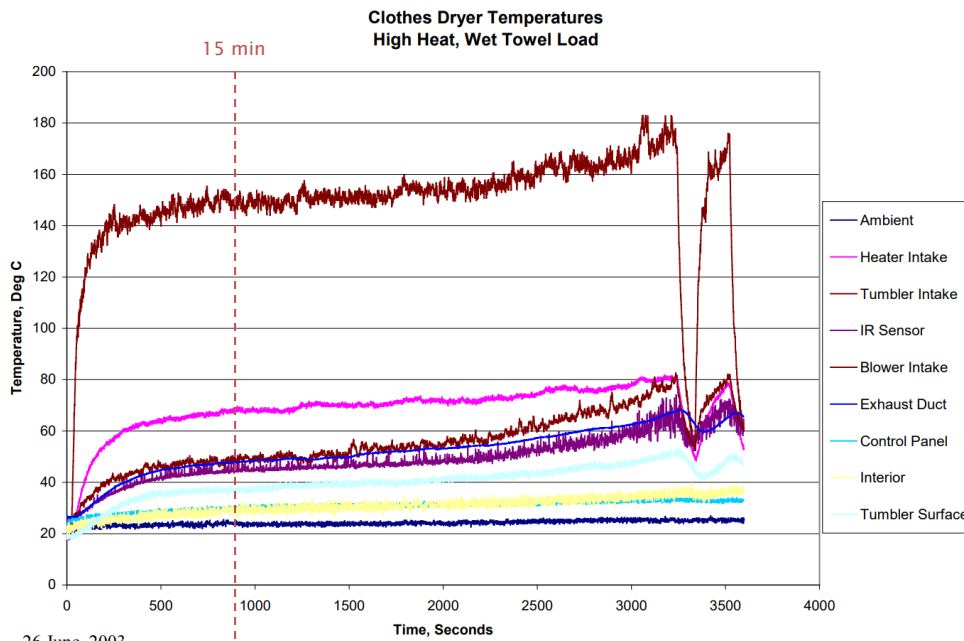
One of the reasons observable moisture issues are not more prevalent is that the temperature and humidity of dryer exhaust varies over the course of the drying cycle. The highest levels of humidity (70% to >90%) are typically experienced in the first 5 to 15 min of a 45 - 60 min drying cycle. During this period the temperature of the exhaust air is kept relatively low due to evaporation of moisture from the clothing. This period of high moisture and low temperature can lead to wetting. As the clothes continue to dry, less water evaporate and the exhaust air temperature rises. This period of low humidity and high temperature can lead to drying. This cycle is shown in Figure 1.4.

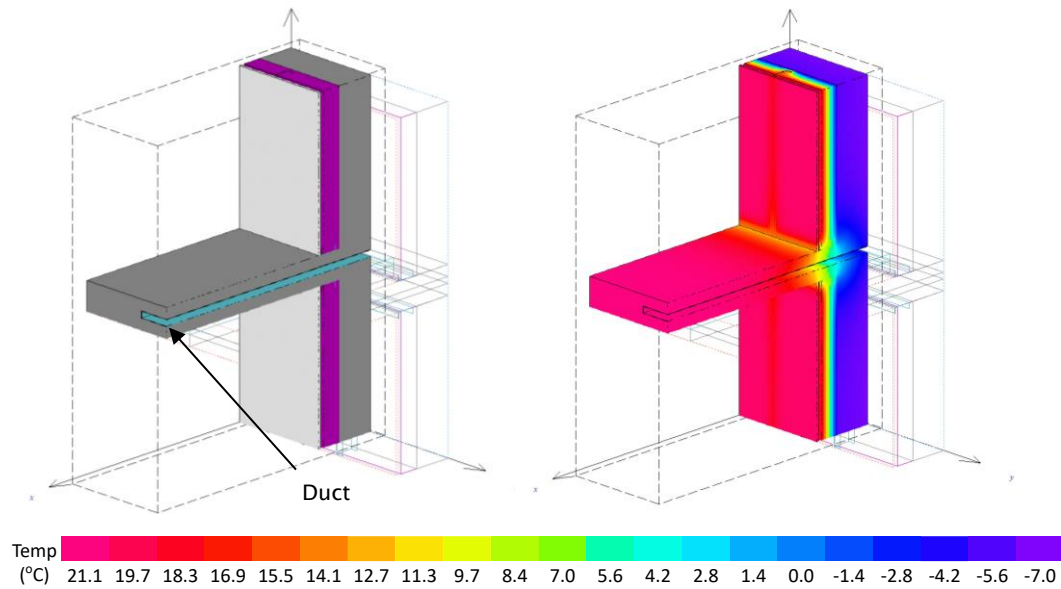
Figure 1.5: Cut-away view of an in-slab duct passing through an interior insulated concrete wall.

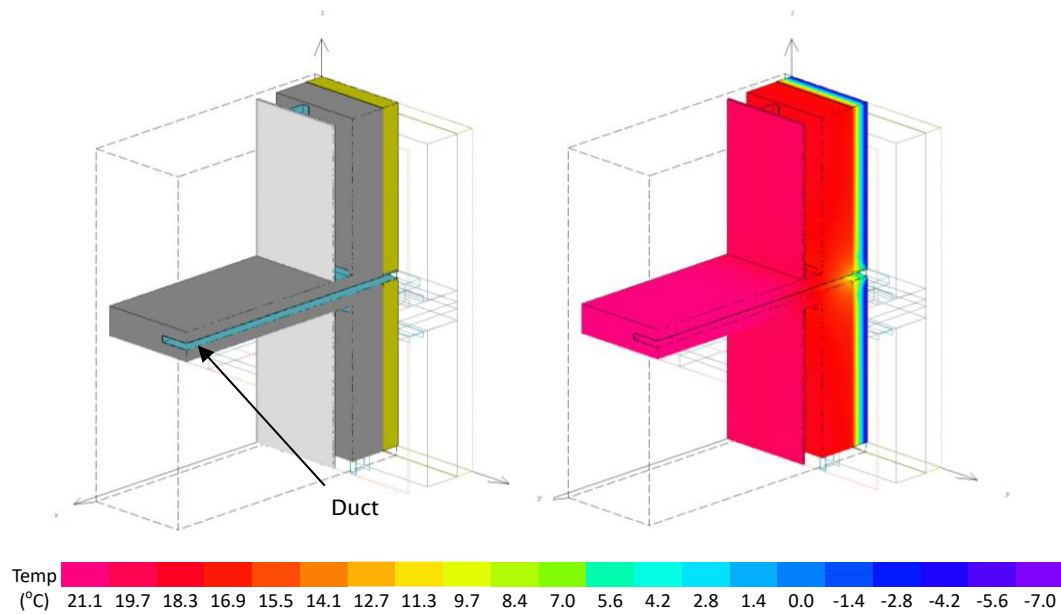
Figure 1.6: Cut-away of an in-slab duct passing through an exterior insulated wall.

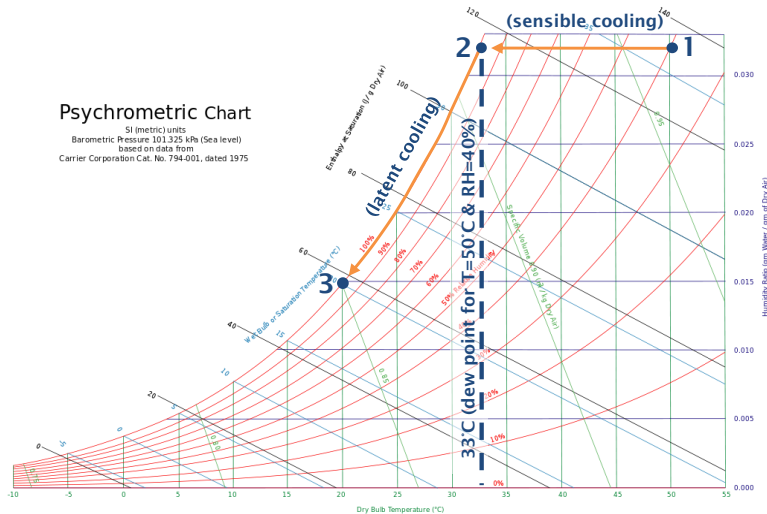
How much water will condense (per minute) if air enters the duct at 50°C and 40% RH (density of 1.04 kg/m³) and is cooled to 20°C at the discharge outlet. The airflow rate is 50 L/s (100 cfm). Assume that the inlet and outlet air properties remain constant.

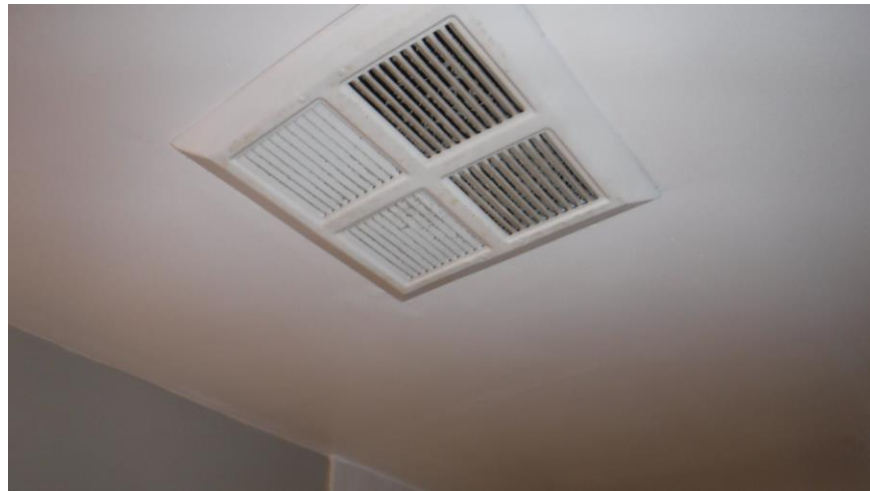
Figure 1.9: Bathroom exhaust fan unit. Air from the interior space can enter the exhaust duct due to the combination of wind, stack effect, and mechanical pressures, where it can then cool and condense.

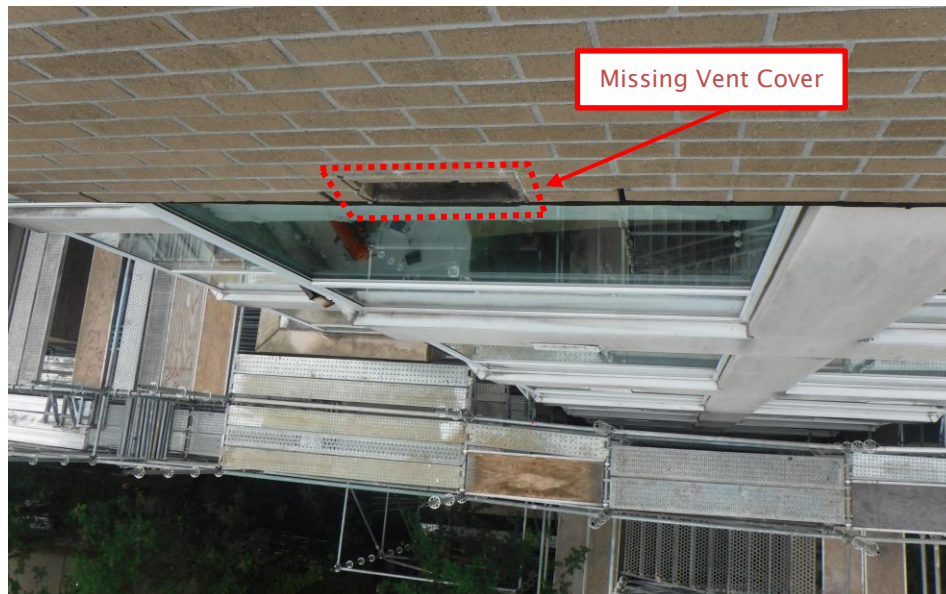
Figure 1.10: Photograph taken of a wall from above showing an exhaust vent opening. Note the vent cover has been removed and the duct is therefore exposed to rainwater.

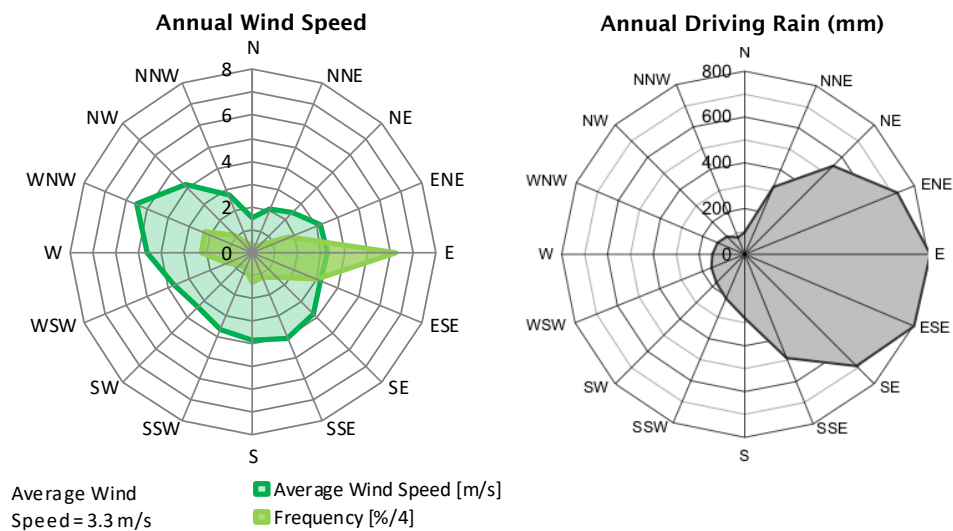
Figure 1.11: Wind rose for Vancouver International airport based on CWEC data

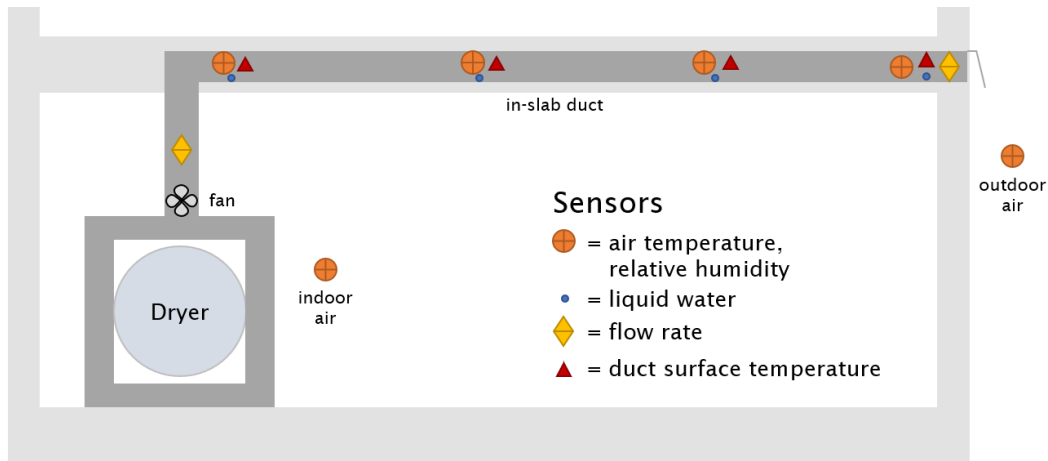
Figure 2.1: Schematic diagram of the experimental setup

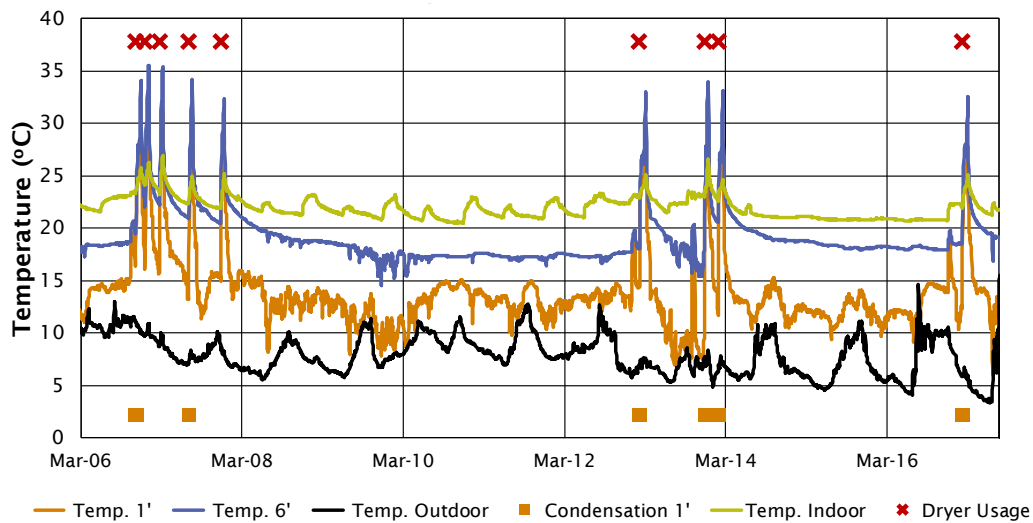
Figure 2.2: Site A – Graph showing temperature at 1' (0.3 m) and 6' (1.8 m) from the duct outlet. Periods of condensation are shown based on the dew point temperature.

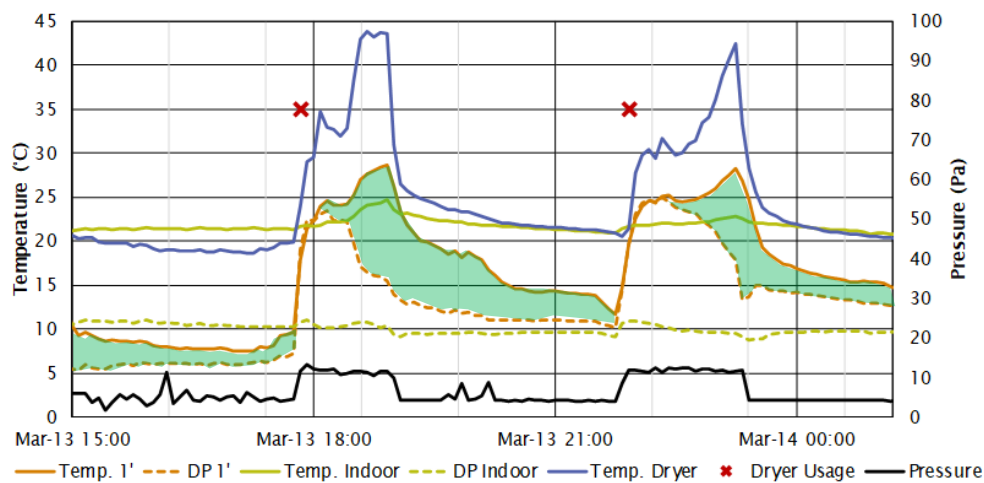
Figure 2.5: Site A - Graph air and dew point temperatures over the course of two dryer cycles. Green area designates when duct temperature is above dew point temperature.

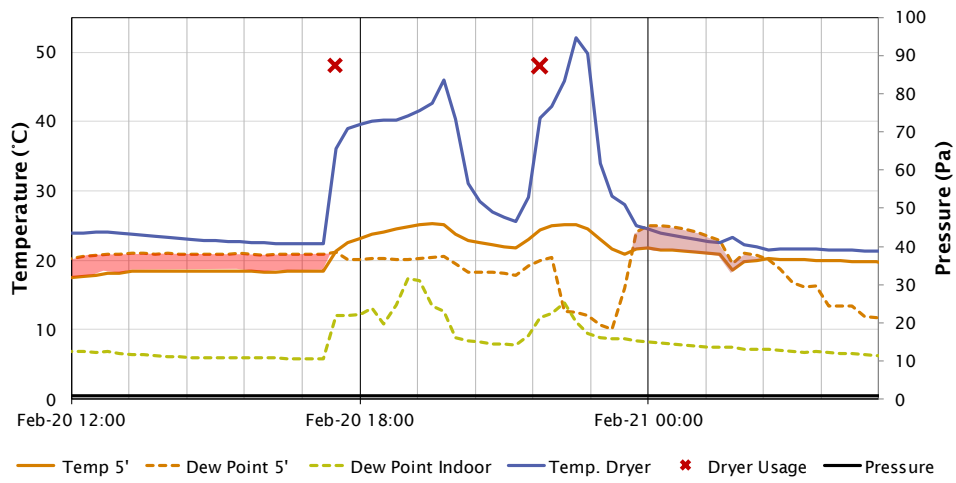
Figure 2.6: Site C – Graph air and dew point temperatures over the course of two dryer cycles. Red area designates when duct temperature is below dew point temperature.

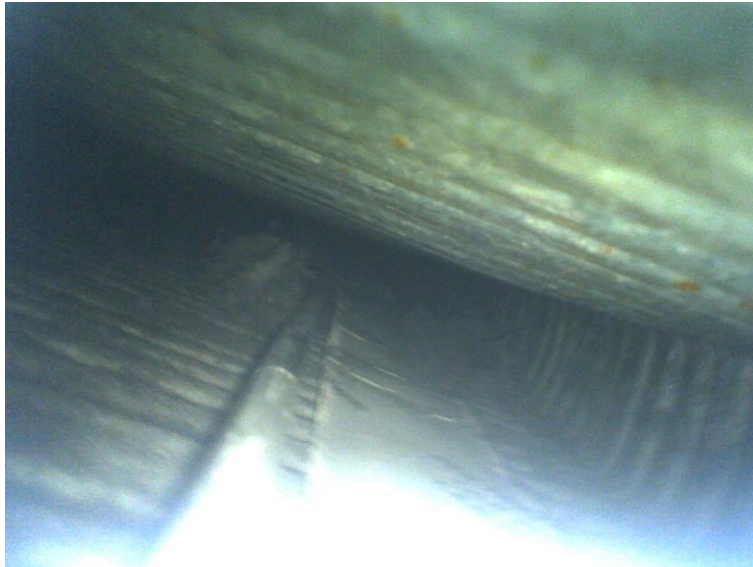
Figure A.1: Photo of the dryer exhaust duct at site A taken during sensor installation.

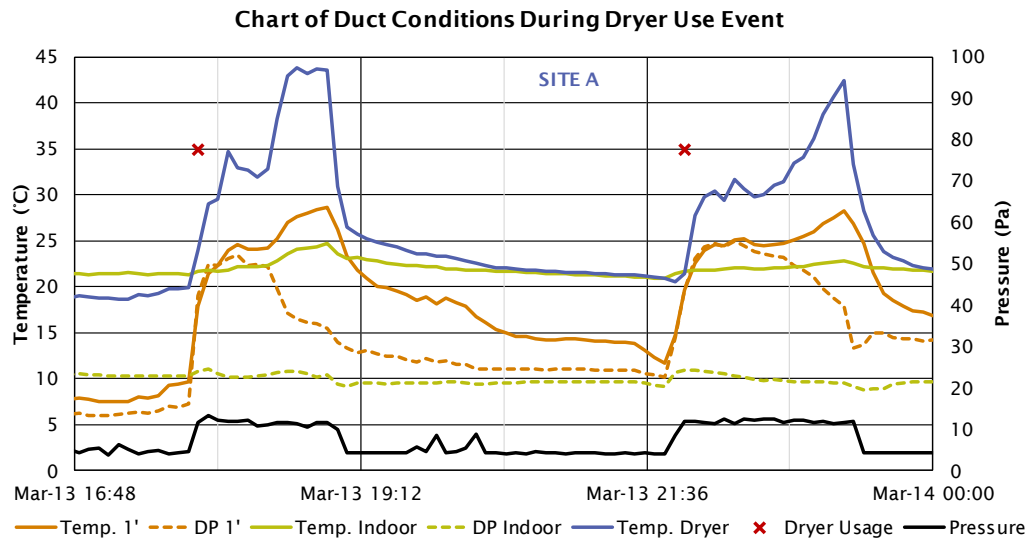
Figure A.4: Graph showing air and dew point temperatures during a typical dryer use cycle for Site A, which had no observable moisture build-up. The dew point temperature rises during the initial moments of the dryer use cycle and gradually decreases as the cycle continues.

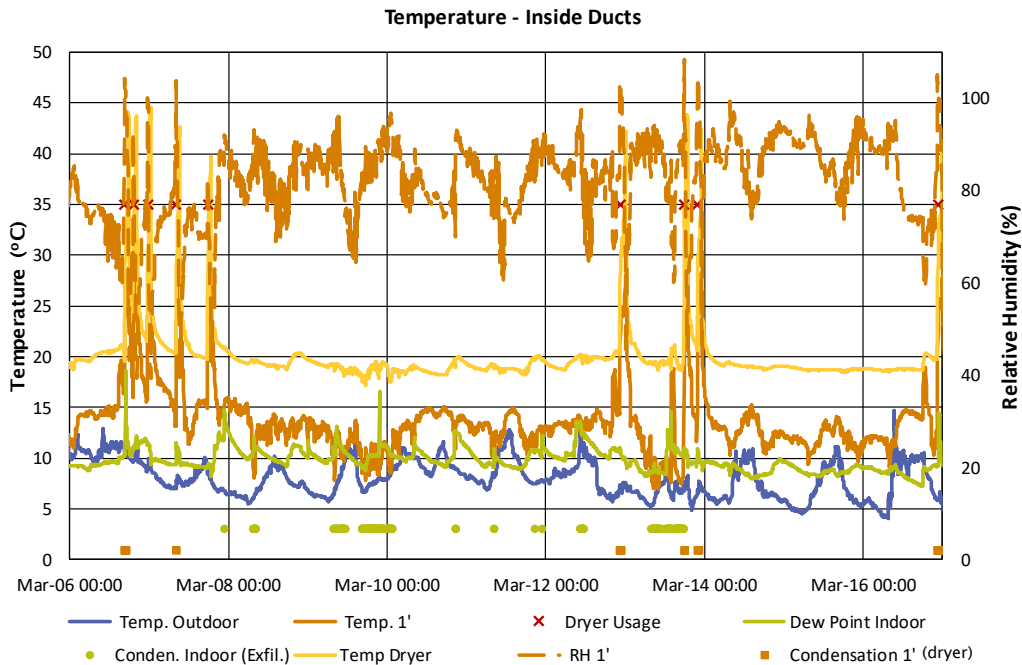
Figure A.5: Graph showing air and dew point temperatures. Dryer usage and condensation periods are also shown.

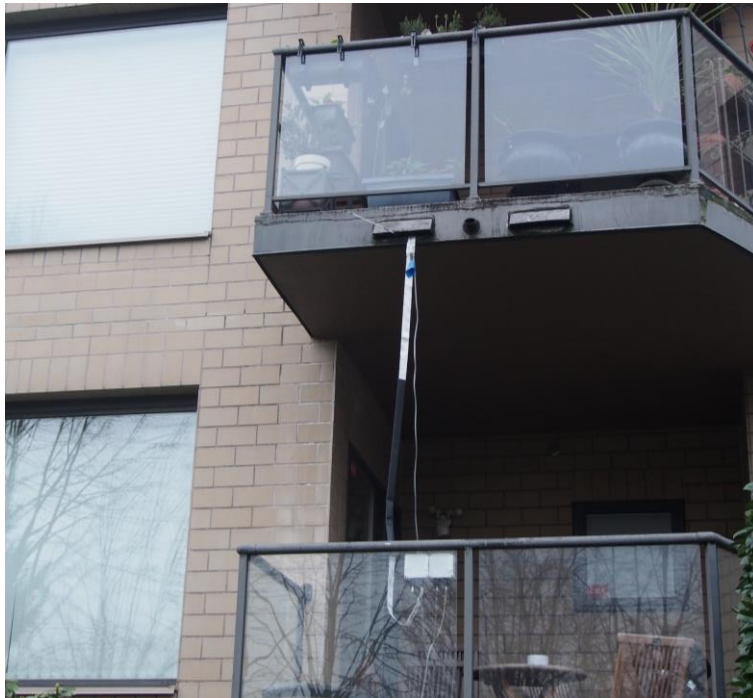
Figure A.7: Photo of the sensor installation at Site B. Dryer exhaust vents at the end of the exposed concrete balcony of the unit above.

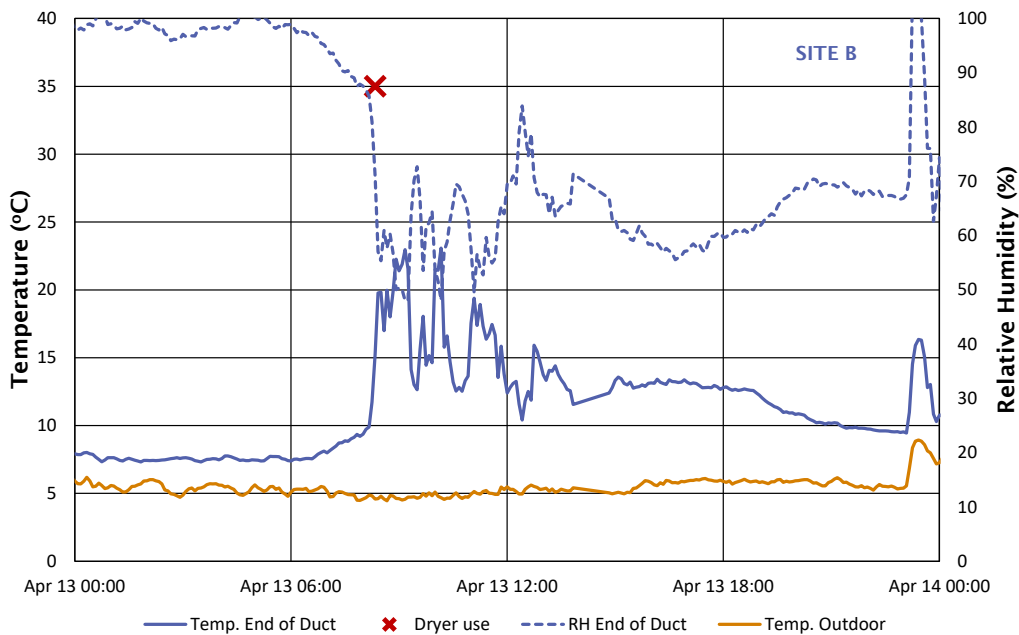
Figure A.9: Graph showing air temperature and RH at the end of the dryer exhaust duct during a typical dryer use cycle for Site B, which had minor observable moisture build-up.

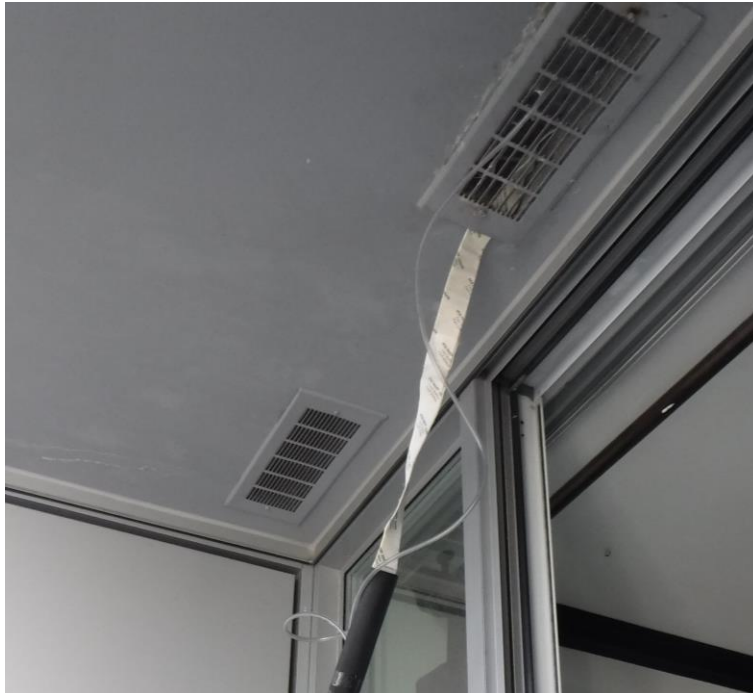
Figure A.11: Photo of the sensor installation at Site C. Dryer exhaust vents under the exposed concrete balcony of the unit above.

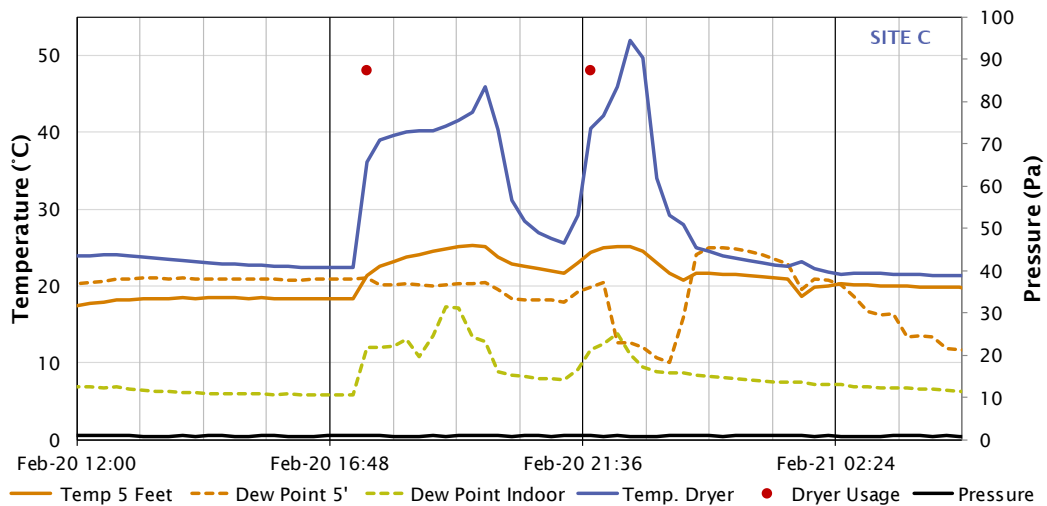
Figure A.13: Graph showing air temperature and RH at the end of the dryer exhaust duct during a typical dryer use cycle for Site C, which had significant moisture issues.

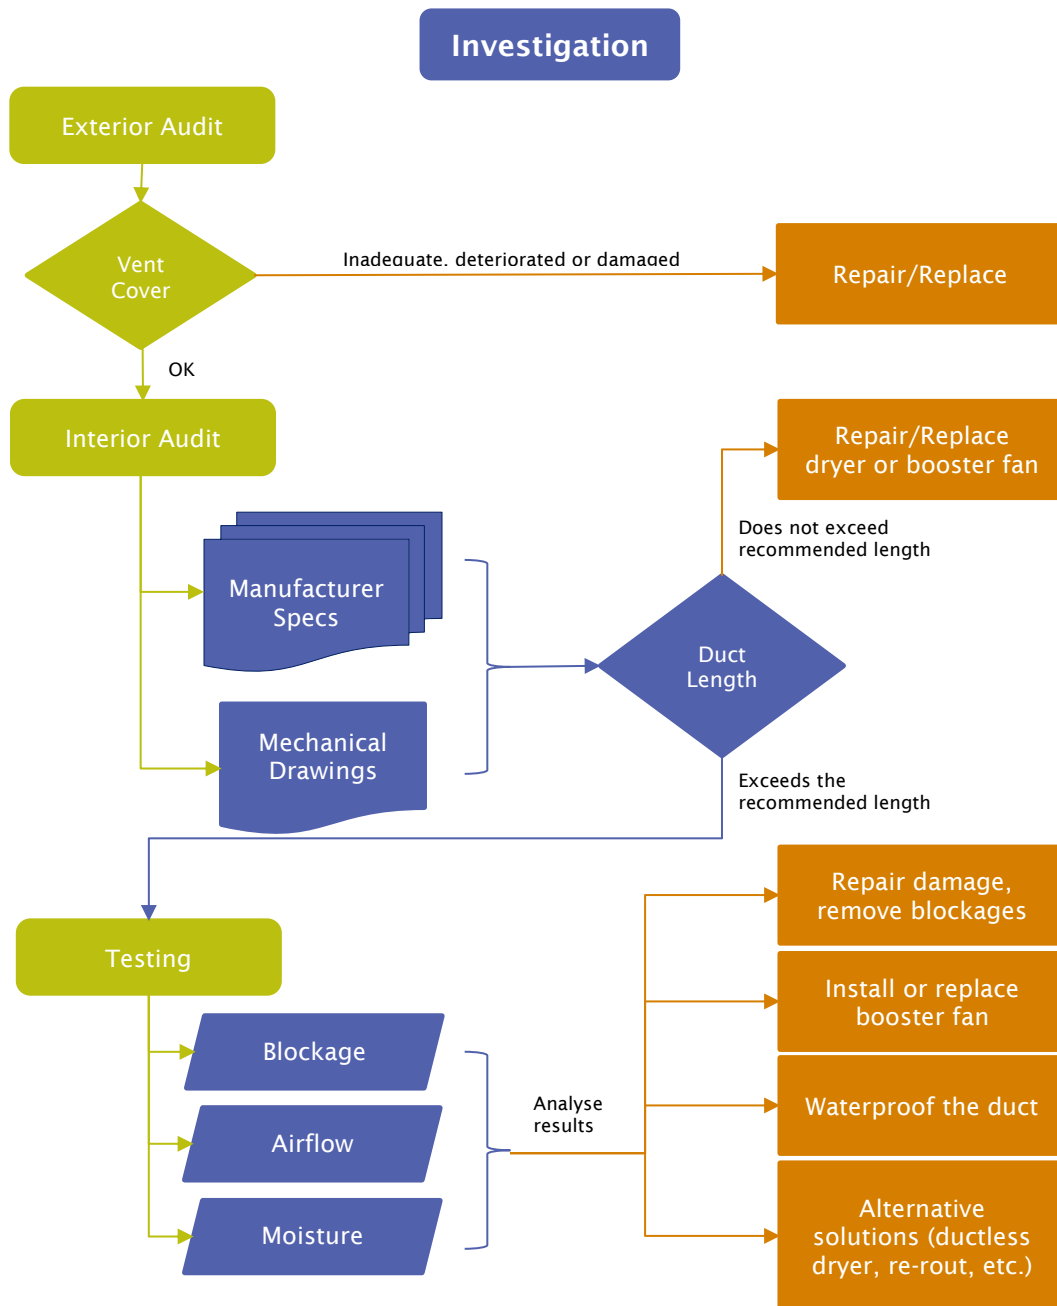
The steps identified in the flowchart above chart are described in more detail below.
