BUILDING ENVELOPE PERFORMANCE MONITORING

Brian Hubbs, P.Eng.¹ and Matthew Hircock²

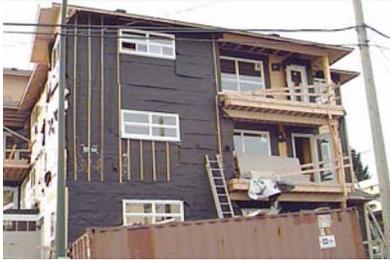
<p>Building 1 Height: 4 stories Project Type: New Construction Frame Type/Sheathing: Wood/Plywood Insulation: Fiberglass Batt in stud cavity Moisture Barrier: 2 layers of Building Paper Cladding: Vinyl Siding on Wood Strapping</p>

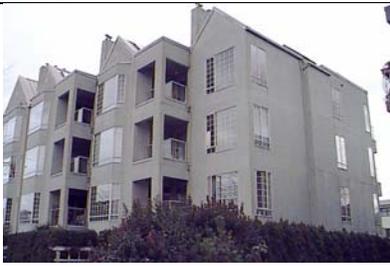
<p>Building 2 Height: 4 stories Project Type: Cladding Rehabilitation Frame Type/Sheathing: Wood/Plywood Insulation: Fiberglass Batt in stud cavity Moisture Barrier: Tyvek commercial wrap Cladding: Stucco on Wood Strapping</p>

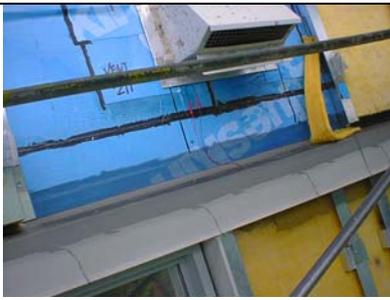
<p>Building 3 Height: 6 stories Project Type: Cladding Rehabilitation Frame Type/Sheathing: Concrete/Dens-Glass Insulation: Rigid Fiberglass on ext. of M.B., fiberglass batt in the stud cavity. Moisture Barrier: Self Adhesive Bitumen Cladding: Stucco on “Z” bars</p>

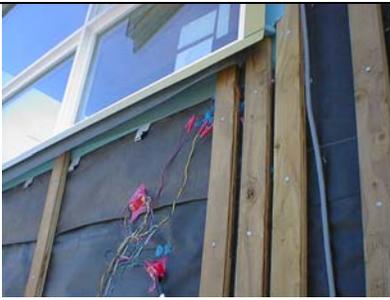
<p>Building 4 Height: 4 stories Project Type: New Construction Frame Type/Sheathing: Wood/Plywood Insulation: Fiberglass Batt in Stud Cavity Moisture Barrier: Building Paper Cladding: Fiber Cement Board on Strapping</p>

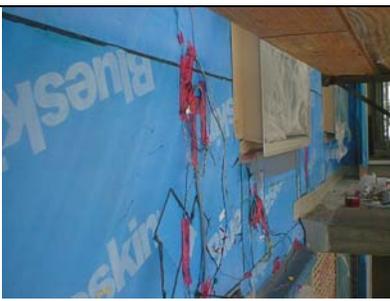
<p>Building 5 Height: 30 stories Project Type: New Construction Frame Type/Sheathing: Concrete/Dens-Glass Insulation: Polystyrene on ext. of M.B., Moisture Barrier: Self Adhesive Bitumen Cladding: Stucco on “Z” bars and Aluminum Window Wall</p>

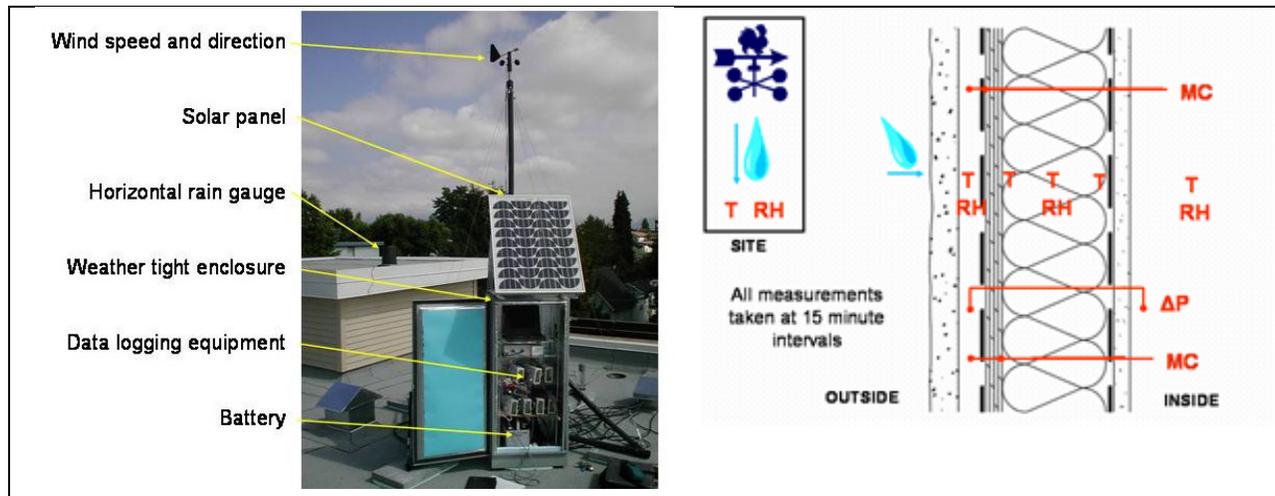
Figure 1 – Monitoring Equipment and Sensor Locations

The monitoring program was designed to measure temperature, wood moisture content, relative humidity, local weather conditions including rainfall, driving rainfall (rain contacting vertical walls), and pressure difference across the walls. A continuous, automatic electronic system records measurements from all sensors every 15 minutes. Five wall cavities on each building were monitored, each cavity contained 4 temperature, 4 moisture content, and 2 relative humidity sensors (Figure 1). On the non-combustible buildings, since it was not possible to take moisture content measurements on the steel studs, gold leaf wetness sensors were used to detect the presence of liquid water in these locations. The data acquisition and logging system is powered by a battery which is charged by a solar panel, this allows the system to collect data during severe storms even if building power is interrupted. Four of the five cavity locations were chosen to be representative of areas most likely to be wetted during severe weather, while the remaining 5th cavity was located in the center of the wall, away from details, to act as a control. Cavities were generally chosen on the east and south elevations at key details such as dryer vents, window sills, balcony transitions and saddle flashings where historically, high moisture levels have been observed (Figure 2).

A description of the equipment and sensors is shown in Table 2.

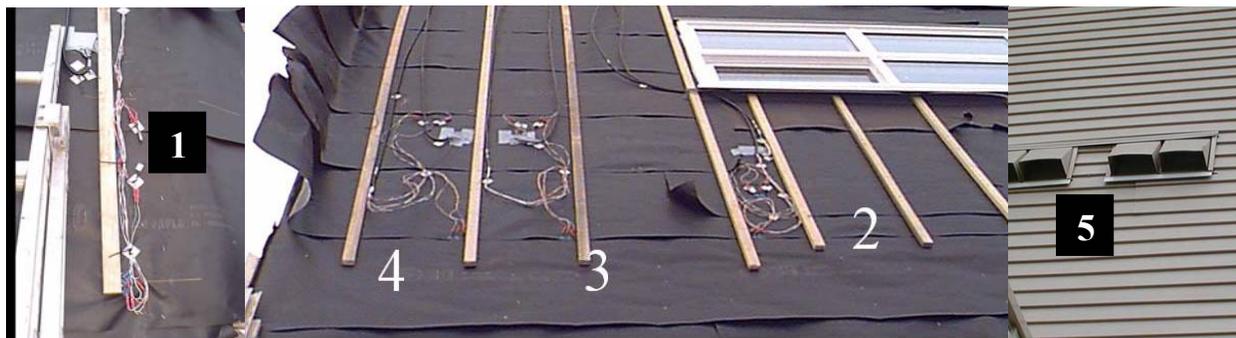
**Figure 2 – Cavity Locations, Building 1
(1-Balcony saddle, 2-Window Corner, 3- Control, 4- Electrical Box, 5- Dryer Vent)**

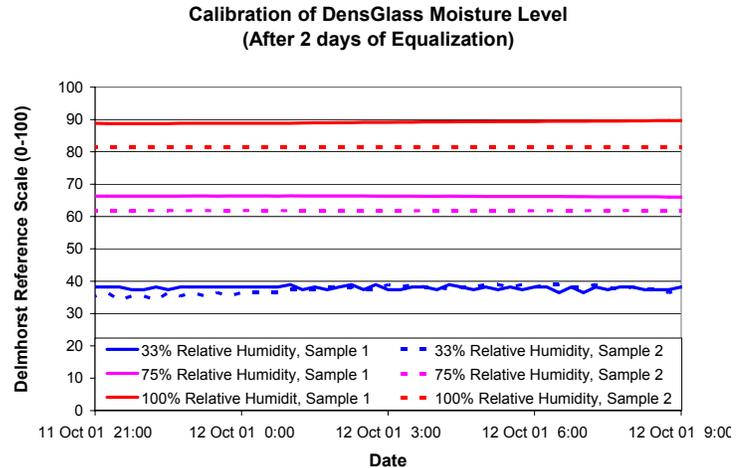
The calibration for plywood samples 1 to 4, using the Lakewood logger, and DensGlass gold Test # 6, using the Campbell Scientific logger is shown in tabular form in Figure 3. The calibration of Dense Glass sample 1 and 2 using the Campbell Scientific logger, is shown graphically in Figure 3.

Figure 3 – Calibration of Moisture Measurements in Plywood and DensGlass

this study indicate that moisture readings in the range of 80 to 90 in Dens-Glass Gold sheathing are indicative of exposure to conditions at or near 100%RH. In addition, during the period in February and March of 2002 when the high readings were observed, the gold leaf wetness sensors were reading levels that indicate condensation on the interior surface of the sheathing. The abnormally high humidity values can be explained by examining the wall assembly in more detail. On Building 3 an exterior insulated rainscreen assembly was used that incorporated an impermeable air/vapour/moisture barrier applied to the exterior sheathing. However, as this was a retrofit, R8 batt insulation was left in the stud space and the polyethylene vapor retarder was removed in most locations. As the temperature cools down across the batt insulation, the amount of moisture that the air can hold decreases, increasing the relative humidity. This phenomenon can be seen on Figure 6a. The calculated relative humidity at the exterior sheathing is at 100% for the majority of the period shown in Figure 6b, and small reductions in moisture content in the sheathing are observed during period of warm exterior temperatures when the calculated relative humidity drops below 100%. The high moisture levels observed in the exterior sheathing were relatively constant throughout the winter of 2002. The moisture level started dropping in mid March and was relatively dry (35-50) between May and September at which time the levels start to increase again. As of October 2002 the moisture level in the exterior sheathing was approaching 75.

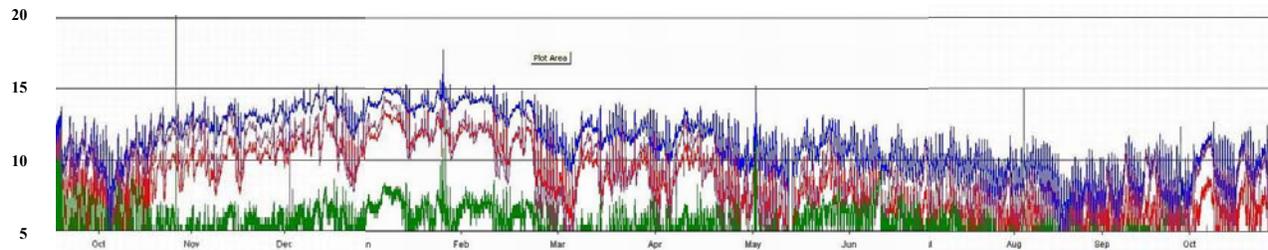
Figure 4 shows the wood moisture content in the control cavity on Building 1. This graph is an example of the typical seasonal wetting and drying cycle that was observed in virtually all cavities, on all buildings. Generally the wood framed walls in the winter months were observed peaking at around 15% MC followed by a drying trend in the summer months. The highest wood moisture content levels were found on Building 1 in Cavity 5 (Figure 5). The higher moisture content identified by the increase in the moisture content in the sheathing directly below the exhaust vent was likely caused by an increase in water infiltration past the shedding surface at the cladding to vent interface. The large spikes throughout the year which can be seen on Figure 5 but not in Figure 4 were caused by usage of the vent itself and contact of the wall components with the warm humid exhaust air.

Figure 4 – Building 1, Cavity 3 (Control) Moisture Content (%), October 2001 to October 2002
Red=Sheathing in Centre of Cavity, Blue=Sheathing near strapping, Green=sill plate, Magenta=Strapping

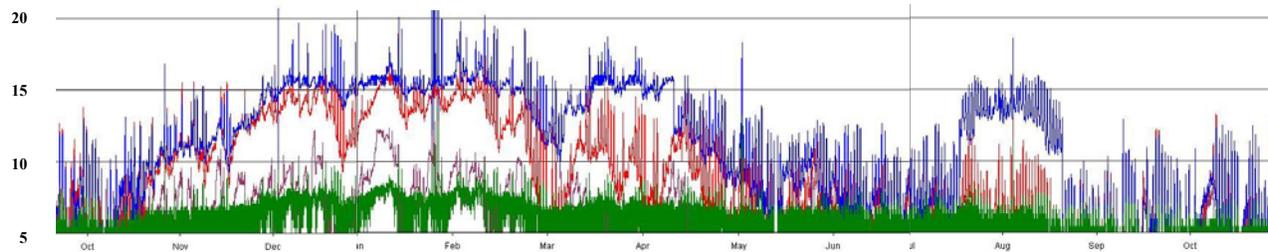
Figure 5 – Building 1, Cavity 5 (Exhaust Vent) Moisture Content (%), October 2001 to October 2002
Red=Sheathing in Centre of Cavity, Blue=Sheathing below vent, Green=sill plate, Magenta=Strapping

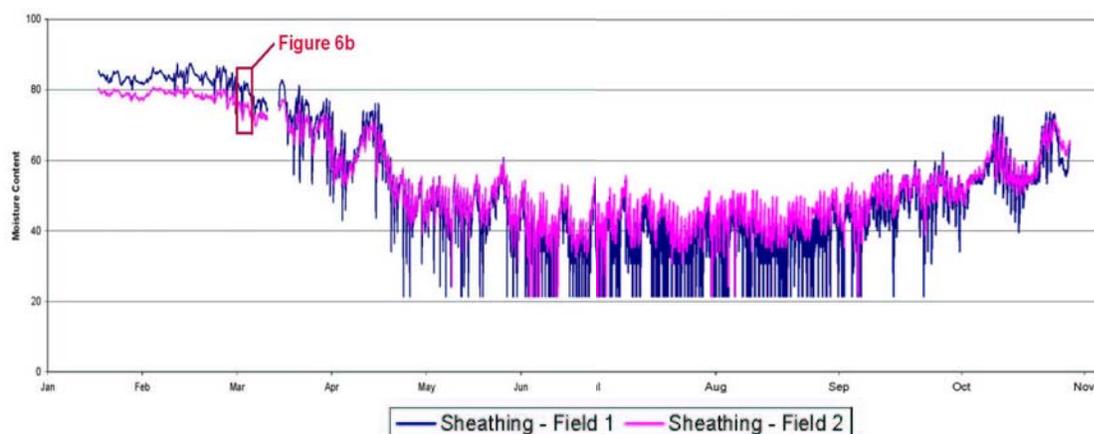
**Figure 6a – Building 3 Cavity 6, Relative Moisture Level (0-100 scale)
January 15, 2002 to October 25, 2002**

While the moisture content results cannot be directly compared between Building 3 and Buildings 1 and 2, the amount of moisture observed in the walls differs significantly. The moisture readings in gypsum sheathing have been calibrated to the 0-100 relative scale common to the Delmhorst BD10 and 2100 moisture meters and therefore, and cannot be compared to wood moisture content readings. Calibration of the moisture sensors performed at the start of

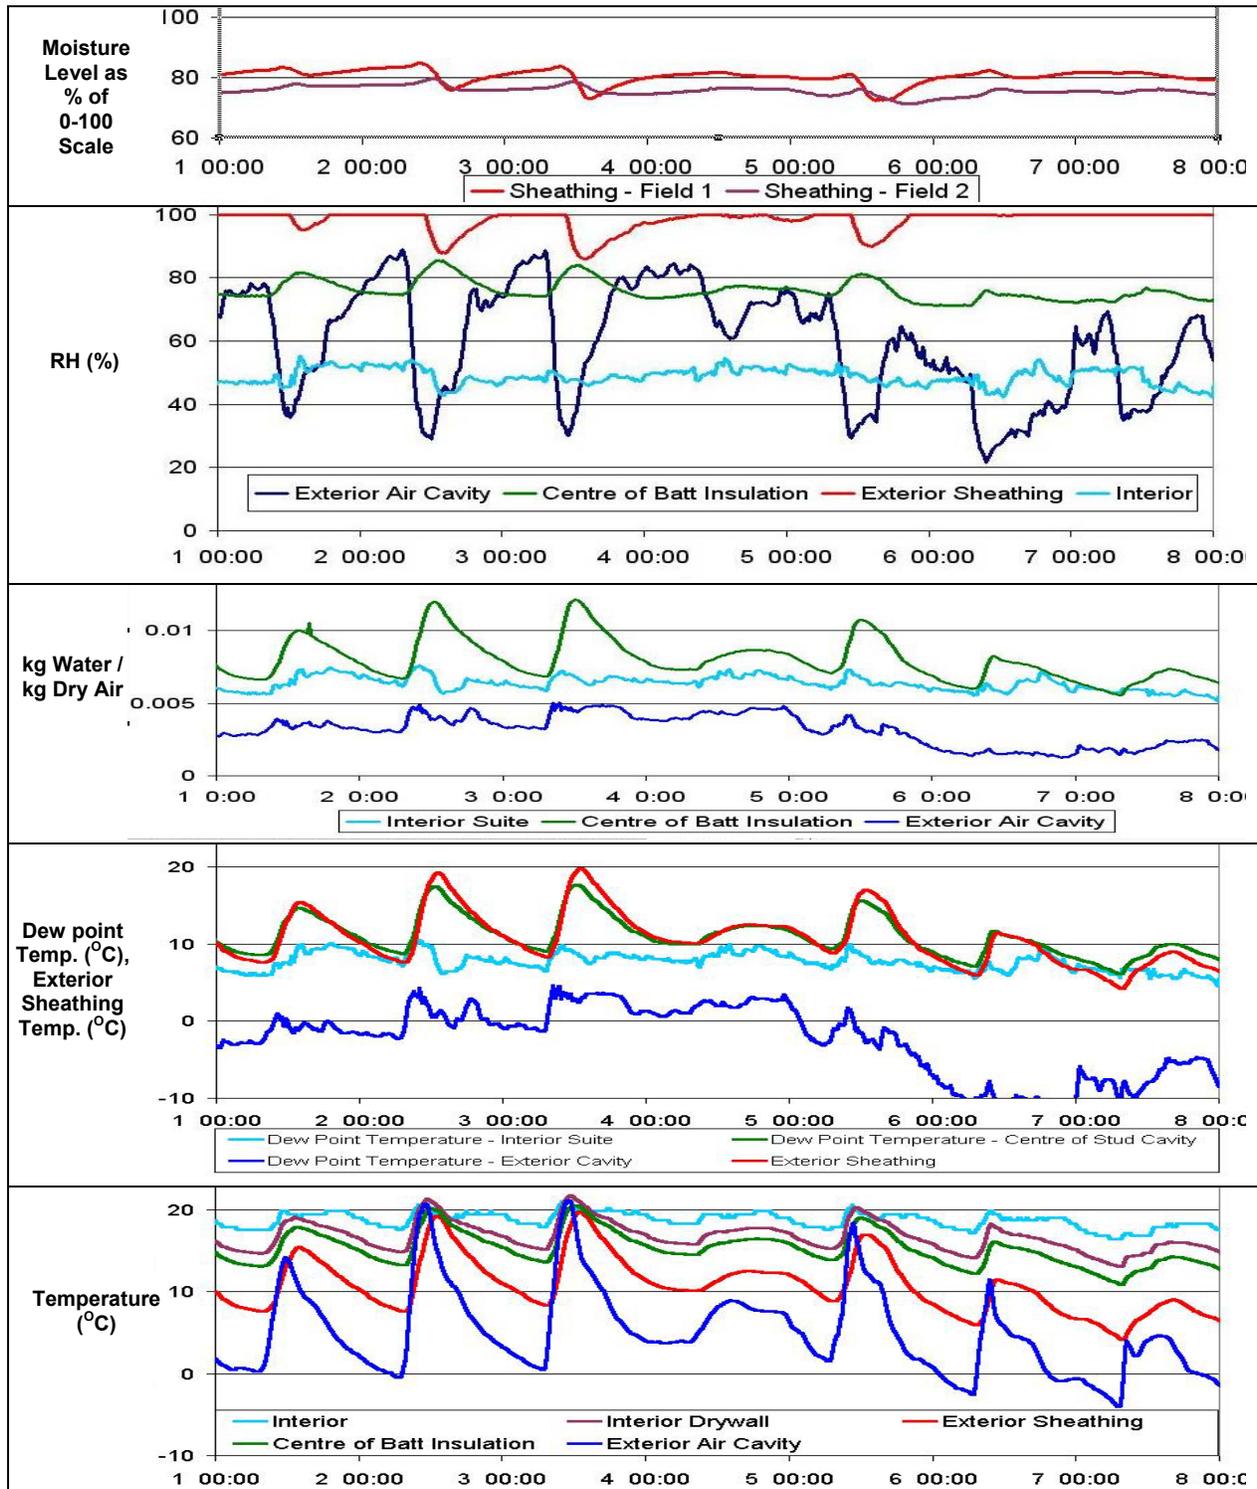
Figure 6b – Relative Moisture Level (0-100 scale), Relative Humidity (%) and Temperature (°C)
Building 3 – Cavity 6 (control), March 1 – March 8, 2002

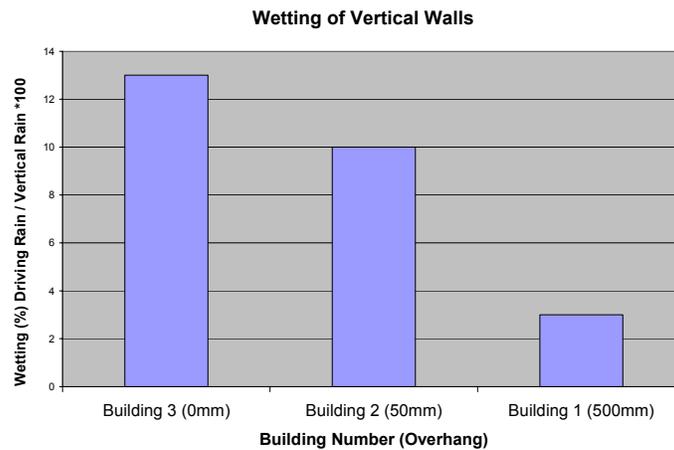
Figure 7 shows this information graphically for the east elevation. It should be noted however, that Figure 7 is based on a very small sample size, with differing external factors that can also

Figure 7 - Driving Rain vs Overhang Width

The relationship between overhang protection and wetting on the walls was examined for Buildings 1, 2 and 3 by dividing the total driving rain by the total vertical rainfall on each building and elevation. The results of this analysis shown on Table 4 indicate that the width of the overhang can significantly impact the amount of wetting from wind driven rain. For example the east wall on Building 2, which has an overhang of 50mm, experienced three times more wetting from driving rain than the east wall on Building 1, which has a roof overhang of 500mm.

influence wetting. The monitoring of many more buildings in similar climactic conditions would be required before an accurate relationship between overhang and wetting can be developed.

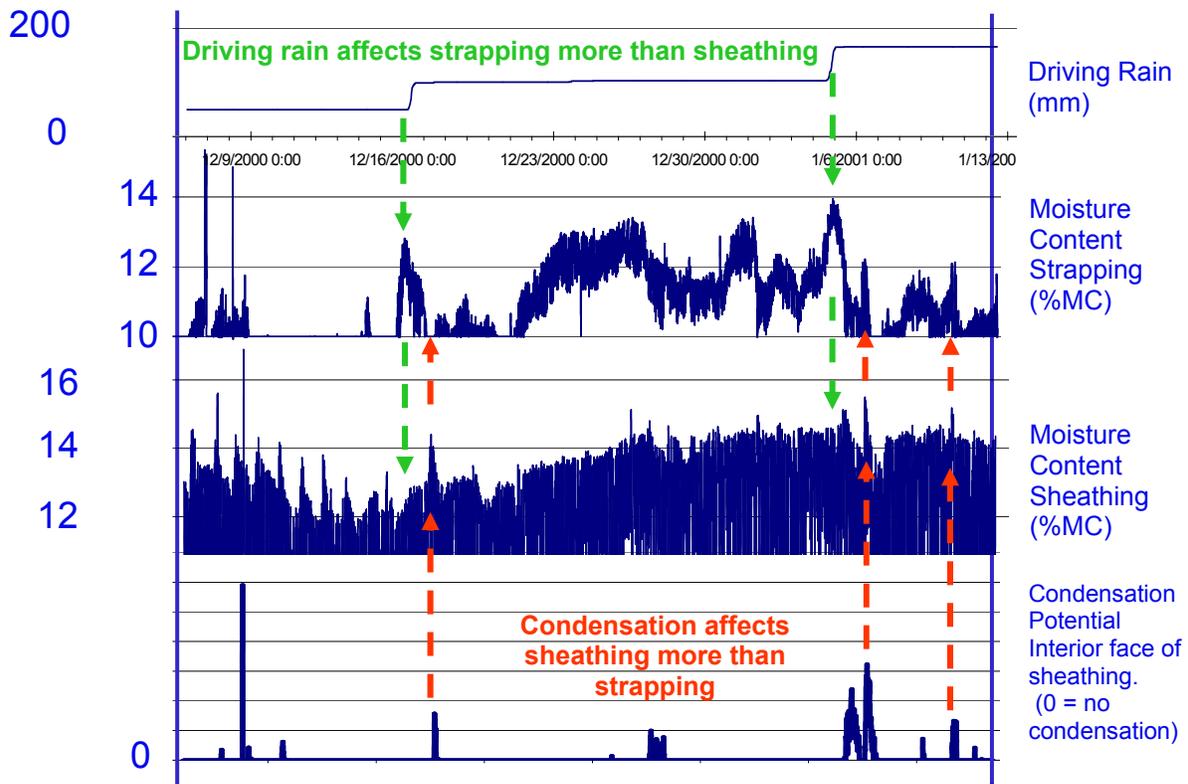
The effect of significant driving rain events can be seen on Figure 8, during the period shown there were 2 significant driving rain events. Each driving rain event was followed by a corresponding increase in the moisture content in the strapping. This was followed again by a corresponding peak in the moisture content of the sheathing, at the same time as there was an increased potential for condensation on the back surface of the sheathing. After both rain events the elevated moisture content quickly returned to normal seasonal levels. The condensation

potential in Figure 8 was derived by subtracting the calculated vapour pressure at the backside of the sheathing from the saturated vapour pressure at the same location. When the calculated value is greater than zero there is a potential for condensation at this surface. Wind driven rain increased moisture content of strapping quickly, but took longer to affect sheathing. In many cases when storm duration is small, sheathing moisture content was unaffected by the driving rain.

**Figure 8 - Condensation Impact on Moisture Content (Winter)
Building 1, Cavity 2 December 6, 2000 to January 12, 2001**

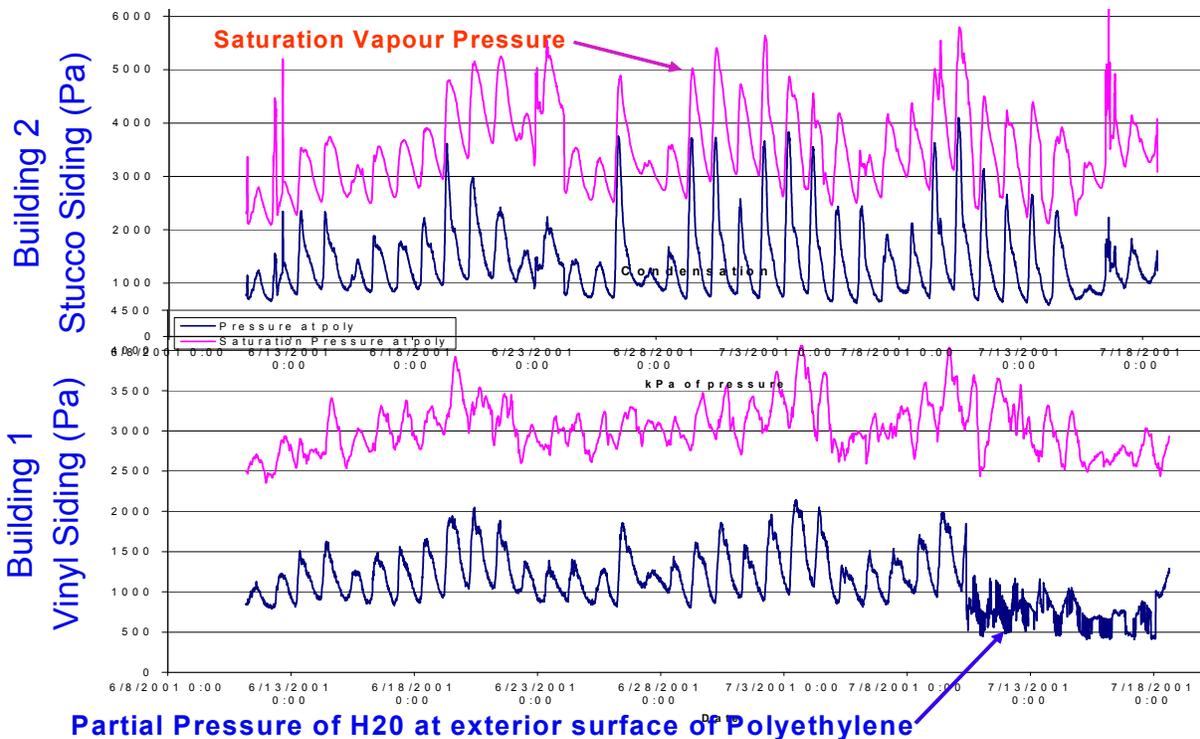
The data was reviewed to examine the effect of inward vapour drive on the moisture content of the sheathing and strapping in Buildings 1 and 2. Sample winter and summer conditions were reviewed in detail to examine the possibility of inward vapour drive. Figure 9 shows the vapour pressure at the exterior side of the polyethylene for a typical hot summer period without precipitation in 2001 between June 10 and July 12. In this period the vapour pressure curve did not touch the saturated vapour pressure curve indicating that no condensation occurred on the exterior of the polyethylene sheet from inward vapour drive. When both buildings are compared, it appears that the vinyl building is more resistant to inward vapour drive than the stucco building. This is likely a result of the higher temperatures generally recorded on the stucco building and possibly the greater water storage capacity of the stucco (Figure 11).

Figure 9 – Buildings 1 and 2 - Inward Vapour Drive Potential (June 10, 2001 to July 12, 2001)

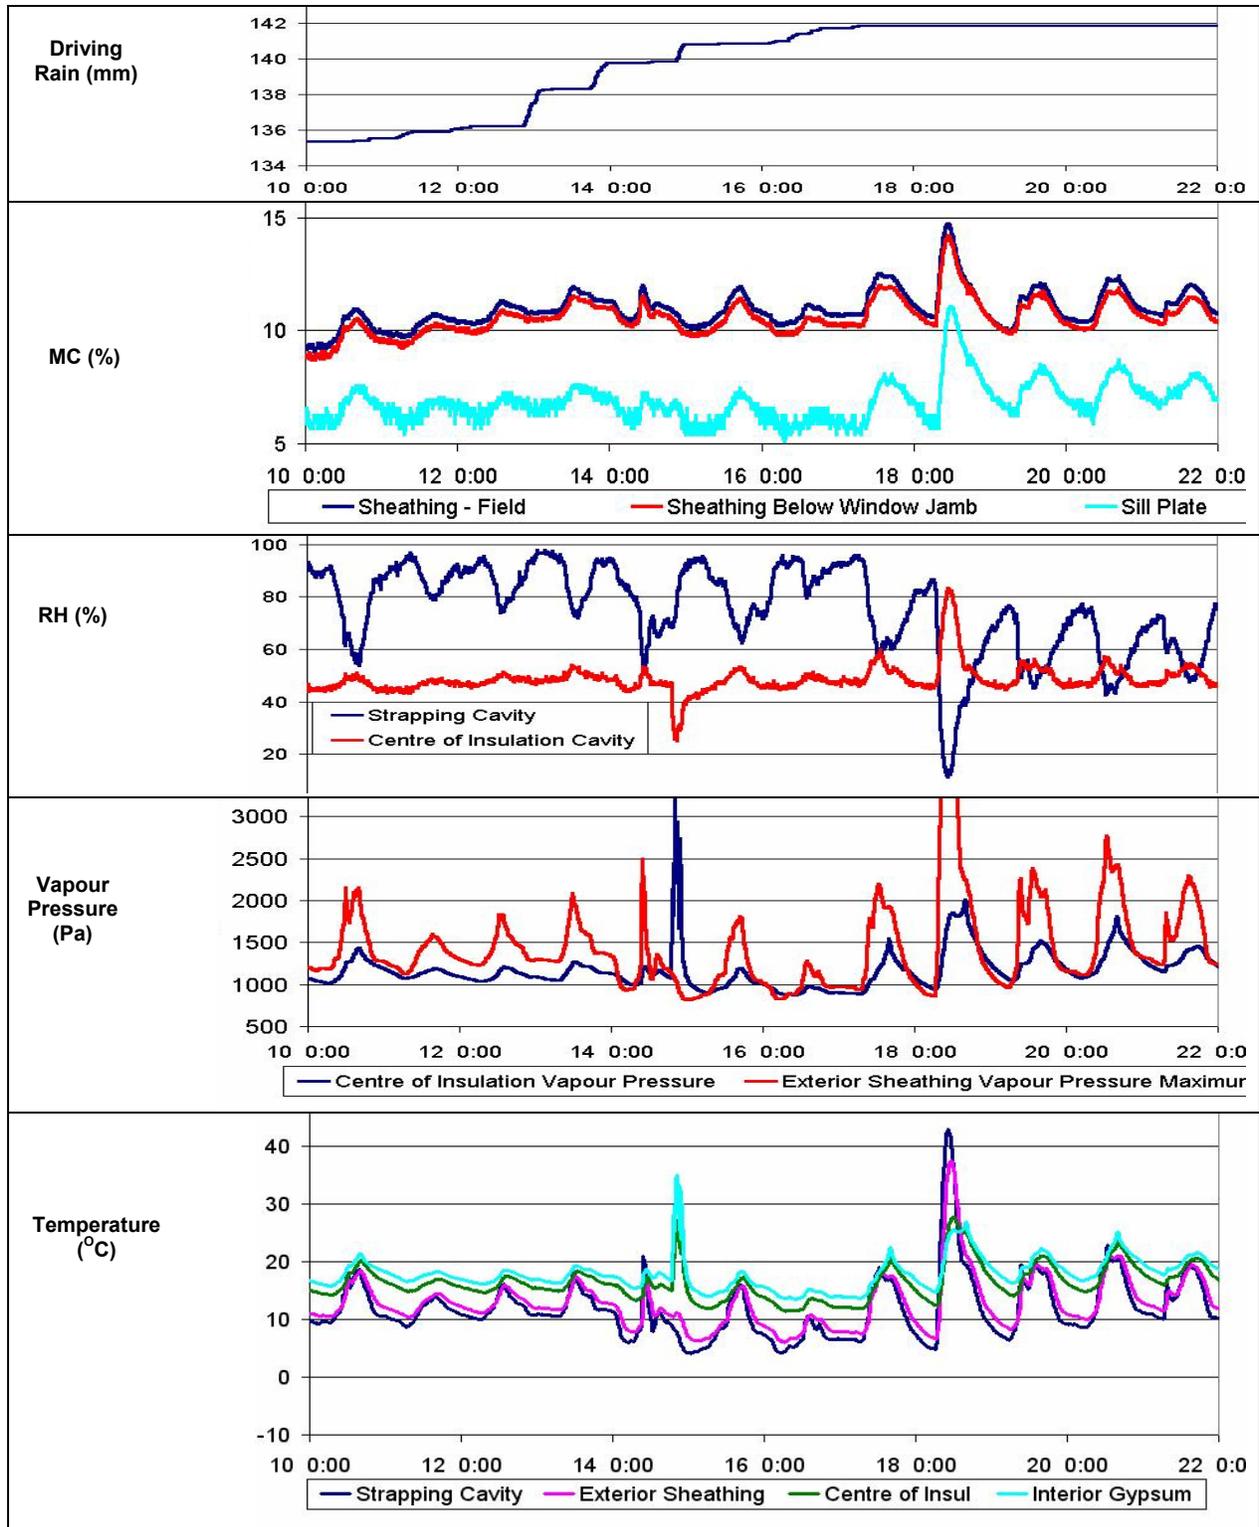
Conversely, when driving rain is present inward vapour drive does occur, having a more significant short term effect on the sheathing moisture content than driving rain alone. In Figure 10 the sheathing moisture content increased slowly during the period when the cladding was wetted from driving rain at a relatively low temperature. From April 10 to the 14th during the heavy rains the moisture content of the sheathing increased from 7% to 12%. However, a much larger and shorter spike in moisture content occurs on April 18th, which was a hot dry day that followed the several days of driving rain. As the wet cladding was heated, the wood moisture content in the sheathing peaked at 15%. The increase in moisture content lasted while the temperatures were elevated but quickly returned to normal with the temperature.

**Figure 10 –Large Driving Rain Event followed by High Temperature Event
Building 2 – Cavity 4, April 10-21, 2002**

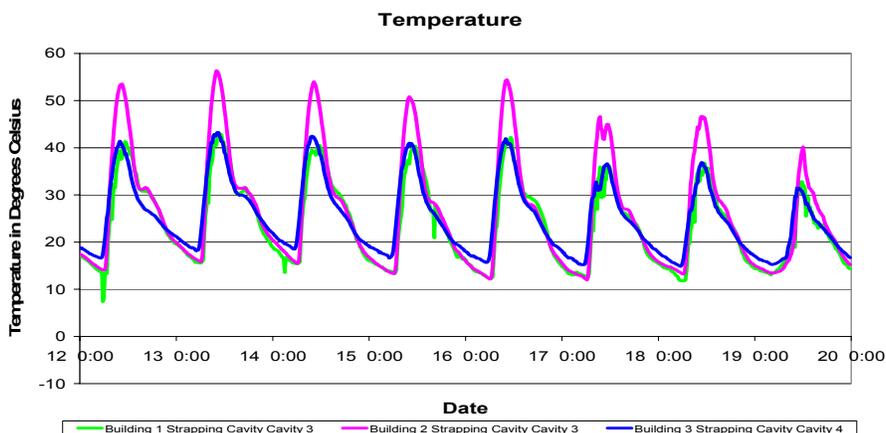
The temperature for the warmest south elevation cavity, during one of the warmest weeks in 2002, is shown for building in Figure 11. In general, the measured temperatures at Building 2 are higher than Buildings 1 and 3. This cannot be explained by colour of the cladding as all buildings have similar colour tones. Slight differences in building orientation, shading from overhangs and trees may be partly responsible for this discrepancy. However, it is suspected that the additional ventilation inherent in the vinyl siding on Building 1, and the larger drainage cavity and conductive metal Z bars behind the stucco cladding on Building 3 also contribute to the measured differences.

**Figure 11 – Cavity Temperature Comparison
August 12, 2002 to August 19, 2002**
