IMPACT OF HEATING AND COOLING OF EXPANDED POLYSTYRENE AND STONE WOOL INSULATIONS ON CONVENTIONAL ROOF PERFORMANCE

Jun Tatara, Dipl.T., Lorne Ricketts, MAsc., P.Eng

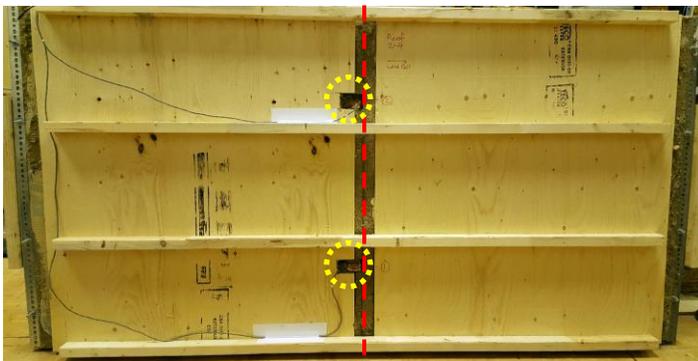
Figure 2: Underside of ribbon-adhered stone wool roof specimen showing gap in plywood and location of the displacement sensors (yellow dashed circles) which were installed at the joint in insulation boards from the underside of the roof specimen.

A gap was created in the plywood substrates and self-adhered vapour barrier that aligns with the joint in the insulation boards. This gap was created to facilitate sensor installation, as shown in Figure 2.

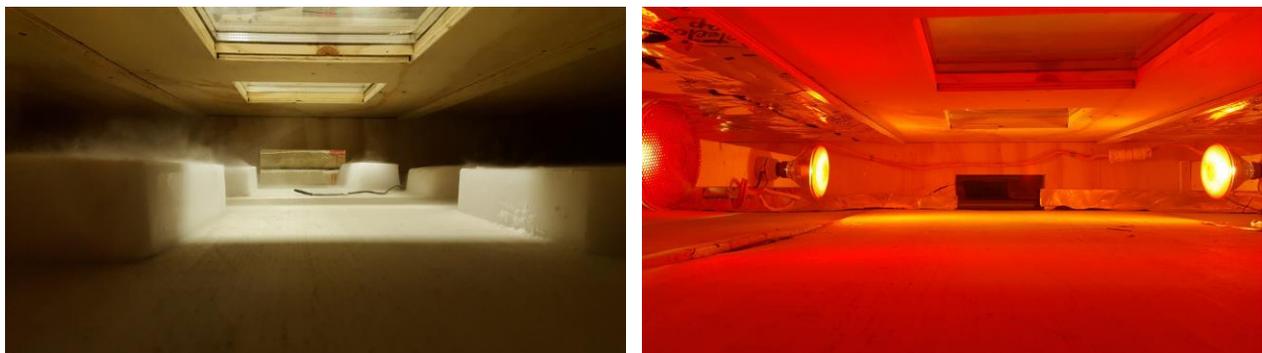
Figure 5: Cold test being performed with dry ice (left) and hot test being performed with heat lamps (right).

To evaluate the impact of hot and cold temperatures on the roof assembly, each roof specimen was installed in the climate chamber and left undisturbed for 24 hours. After this time, the cooling cycle was performed. The specimen was allowed to return to equilibrium temperature before the heating cycle. The heating cycle was performed until insulation temperature reached 90°C (Figure 5). This heating temperature set point was determined based on roof monitoring data from an on-going field monitoring study of a large roof on an industrial building in Chilliwack, within the Lower Mainland of British Columbia. The data from a 4-year monitoring period (2013 to 2016) indicate that on a typical year, cap sheet temperatures of the black SBS membrane experienced approximately 102 hours of temperature above 70°C and approximately 5 hours above 80°C.

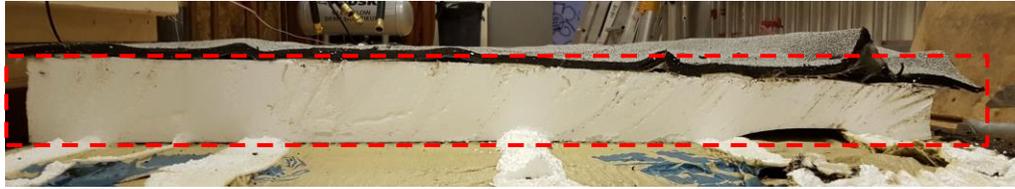
Figure 11: Cross-section (perpendicular to length of specimen) view of ribbon-adhered EPS roof specimen (Roof 2) after heating test. The red dashed line indicates the original dimension of the EPS insulation.

Note that uneven shrinkage of EPS insulation is likely due to slightly uneven heating in the climate chamber, and it is likely that there was a hot spot where the shrinkage is largest (right side).

Thermal expansion and contraction, as well as shrinkage of EPS insulation takes place in all three dimensions (Figure 11); however, the gap measurements only illustrate one-dimensional movement. Once the roof specimens were allowed to cool down to 22°C after the heating cycle, they were disassembled to make visual and physical observations. The original dimension of the EPS insulation is approximately indicated by red dashed line.

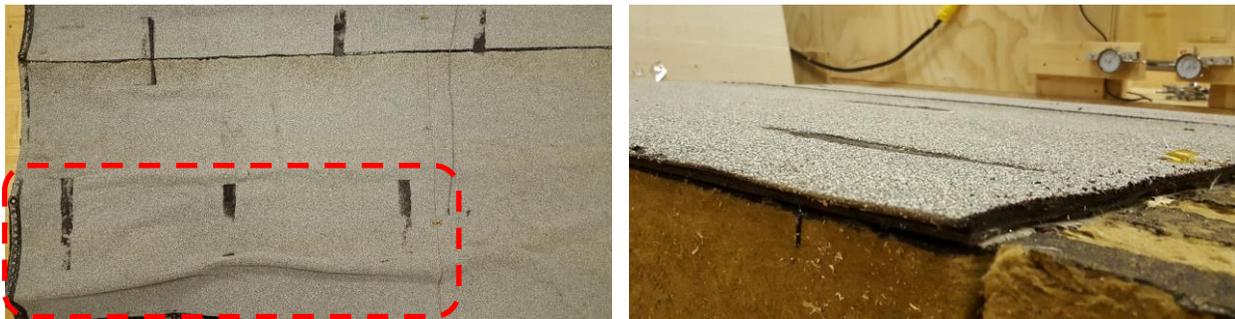
Figure 12: Photos of the ribbon-adhered EPS roof specimen (Roof 2, left) and SW roof specimen (Roof 5, right) after heating test showing creasing of the roof membrane in Roof 2 and no creasing in Roof 5. These two roof specimens are identical in construction other than the insulation type.

Upon visual inspection, significant ridging and wrinkling of the SBS roof membrane along the length of the ribbon-adhered roof specimen with EPS insulation (Roof 2) was observed—as indicated by the red dashed box in Figure 12—while the SBS roof membrane on the ribbon-adhered SW roof specimen remained flat.

The comparison of these specimens confirmed that it was possible in relatively extreme conditions to reproduce creasing of the SBS roof membrane similar to that observed in the field. Furthermore, it indicated that a potential cause of the wrinkling is the movement of the insulation within the assembly, as insulation type is the only difference between these two assemblies (Roofs 2 and Roof 5). This finding reinforces R.G. Turenne's speculation (although his paper focused on temperature induced stress on the roof membrane) that dimensional changes (moisture and/or thermal) and instability of insulation materials that provide the substrate for roof membranes may be responsible for premature failures of the membrane (Turenne, 1976).

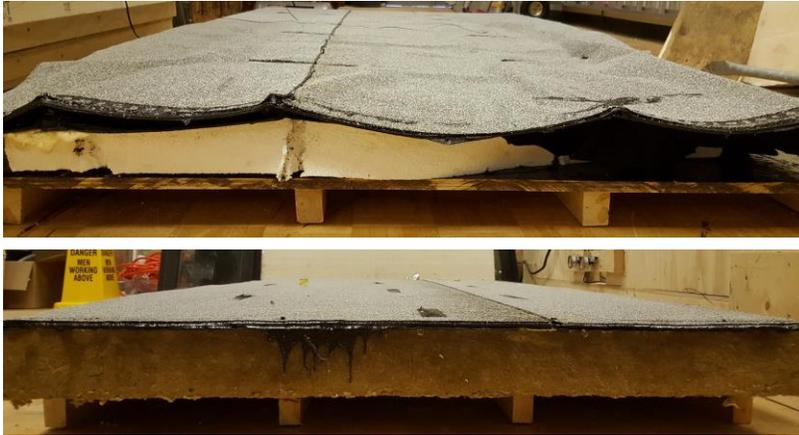
Figure 13: Photos of Roof 2 (EPS, top) and Roof 5 (SW, bottom) after heating test. Note that no deformation of SBS roof membrane was observed in either specimen after the cooling test before heating test.

It is likely that as the roof specimen temperature was raised, the SBS roof membrane and asphalt-based cover board softened and did little to resist movement (shrinkage) of the EPS insulation; while the SW insulation provided a more stable substrate throughout the test temperature range (-15°C to 90°C) and resulted in the difference in performance shown in photos taken after heating test provided in Figure 13.

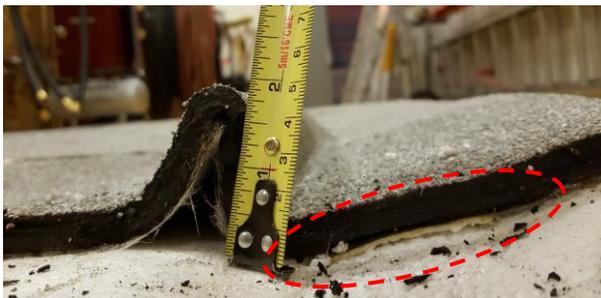
Figure 15: Significant SBS roof membrane and cover board ridging observed with ribbon-adhered EPS roof specimen with asphalt-based cover board (Roof 2). Note that ridging occurred adjacent to the location of an adhesive ribbon as indicated by the red dashed circle.

The SBS roof membrane on the ribbon-adhered EPS roof specimen (Roof 2) experienced ridging along the length of the specimen typically between the ribbons of the adhesive as shown in Figure 14 and Figure 15.
