BUILDING ENVELOPE TECHNOLOGY SYMPOSIUM

MEASURED DRYING ABILITY OF COMPACT LOW-SLOPE ROOFS

RDH BUILDING SCIENCE LABORATORIES

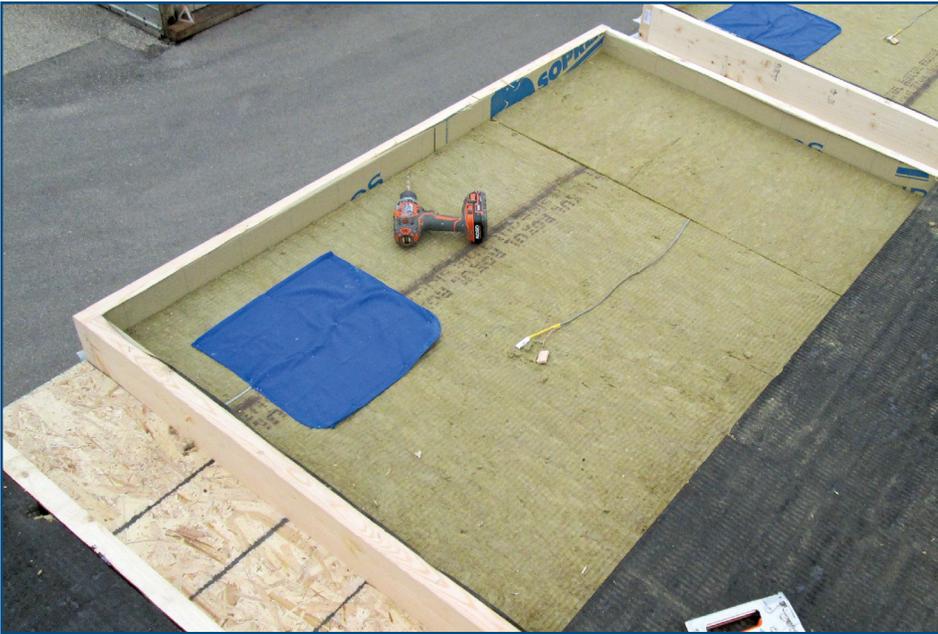
Figure 2 – Installed wetting system with water storage medium and injection tube.

A wetting system was installed in each of the roof assemblies as shown by the blue squares in the schematic drawing (Figure 1) and in the installation photo (Figure 2). The wetting system allowed a controlled amount of water to be injected to a controlled location, simulating a roof leak or construction moisture between the layers of stone wool insulation. The objective of injecting water into the roof assembly is to determine the redistribution of the moisture and to determine the relative drying ability between the different roof assemblies. The wetting events were conducted for five days each, starting June 6, 2016; October 17, 2016; and June 26, 2017.

Figure 3 and *Figure 4* show the standard combination of RH, moisture content, and temperature sensors installed in the roof panels as described in *Figure 1*. A plastic tube was installed to the centre of the wetting storage media from the interior of the test hut to enable a controlled amount of water to be injected to a controlled location (shown in *Figure 2*).

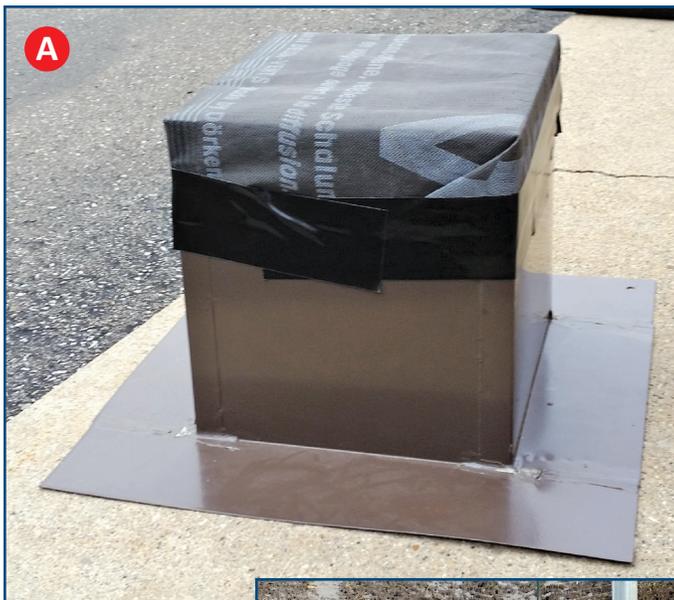
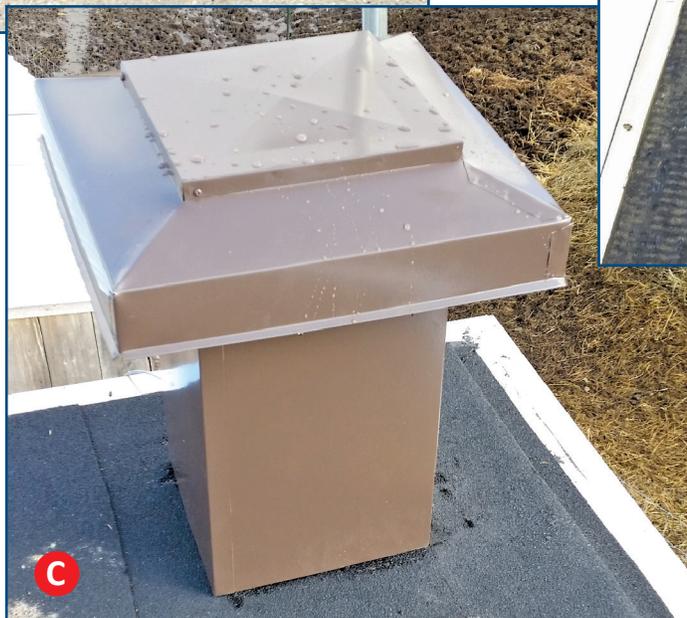
Figure 5 – Roof 1 vapour diffusion port construction steps, showing A) an air barrier membrane installed on open top of vapour diffusion apparatus and taped to the sides, B) black asphalt facer being removed from the roof insulation at the vapour diffusion port location, and C) vapour diffusion port on finished roof assembly.

Roof Panel 1 was constructed with an exterior vapour diffusion port as seen in the *Figure 1* schematic and the *Figure 5C* photo. The intent of the vapour diffusion port is to allow moisture that becomes trapped within the roofing insulation to dry outward via vapour diffusion (since the stone wool insulation is vapour-permeable). The vapour diffusion port is a sheet metal box with an open top and bottom and a flange on the bottom that is integrated between the two layers of the roof membrane. A vapour-permeable air barrier sheathing membrane (approximately 9000 ng/Pa·s·m² [160 perms]) was installed over the vapour diffusion port and taped to the sides before the cap was installed (*Figure 5A*), ensuring no air circulation between the exterior environment and interior of the vapour diffusion port and the insulation material.
