BUILDING SCIENCE LIVE
SEPTEMBER 16, 2020

Considerations for Pre-1940s Steel Windows

Sarah Gray, P.Eng., CAHP
and
Megan Cross-Wilkinson, BASc.

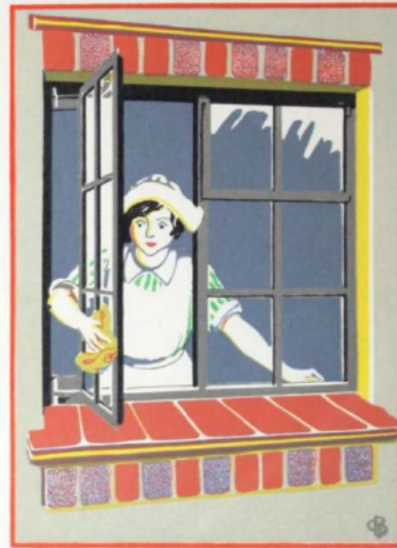
HOPE'S CLEANING HINGES

A Hope V.2.T Standard Window, provided with cleaning hinges.

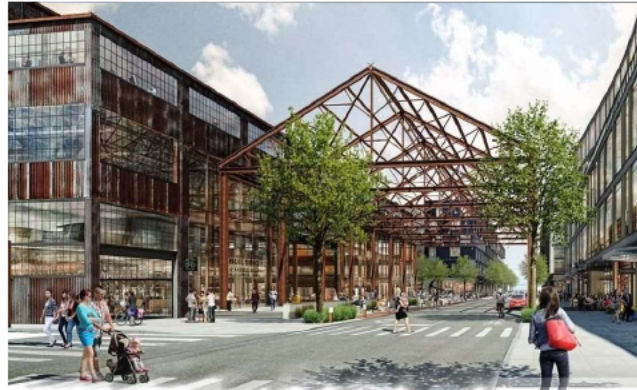
Pier 70 Building 12, San Francisco, CA

Built circa 1940, historically significant original shipbuilding facility turned into maker's and commercial space

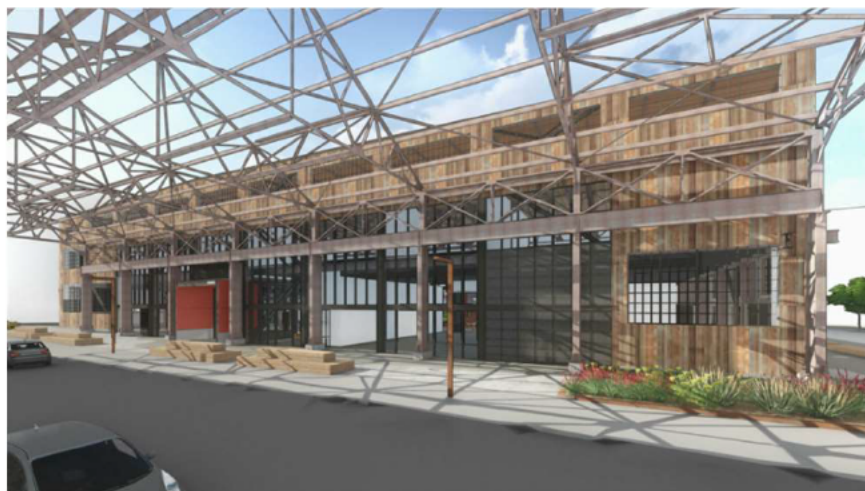
PERSPECTIVE - SOUTH FACADE ALONG 22ND STREET

Building Description

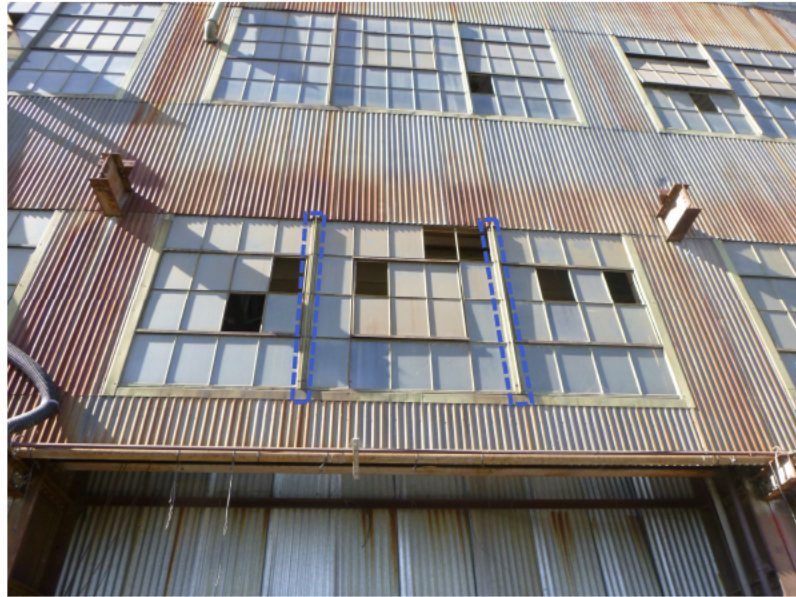
- Original windows, steel frames
- Two main configurations
- Vertical mullioned joints to create large ribbon-style window

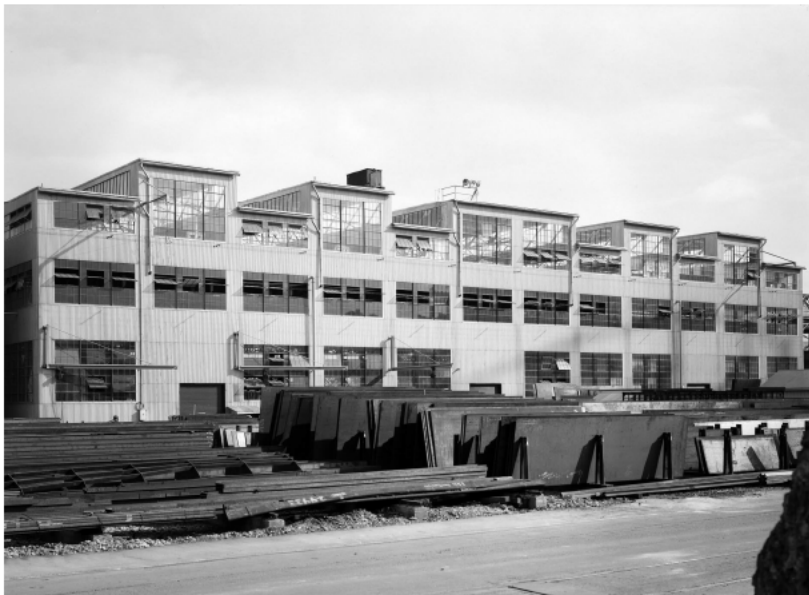
- Operable vents
 - Pivot, hinging at center of light
 - Bent/warped/oxide jacking, many not closing or lacking locking mechanism
 - Maintaining operability desired

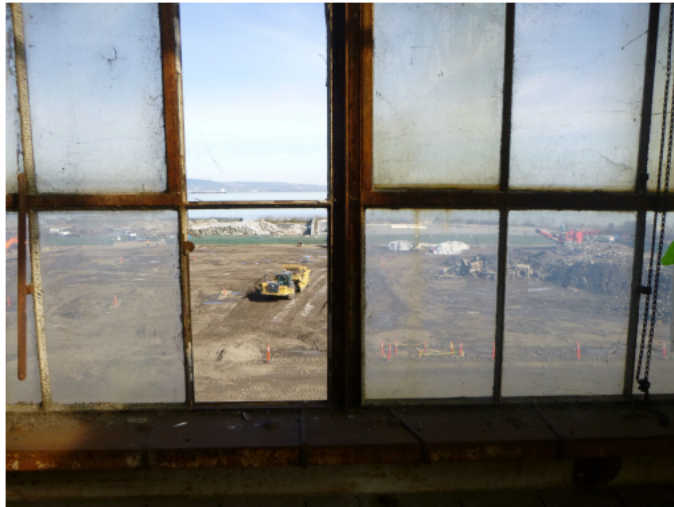
- Single pane glass
 - 12" x 18"
 - Large percentage of glass broken
- Interior glazed
- Retained with clips and glazing putty
- Abatement required for paint and putty removal for re-glazing

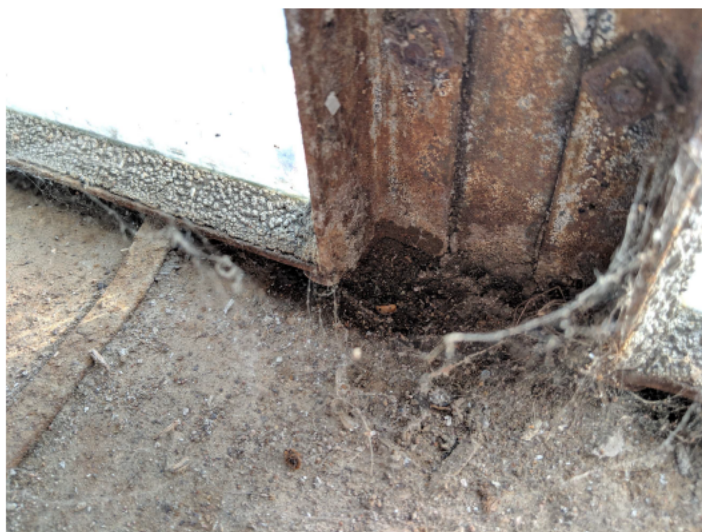
- Determine leak paths through:
 - Frame joinery and operable vents
 - Head, jamb, sill interface
 - Glazing putty original; aged/crazed
 - Vertical mullioned joint

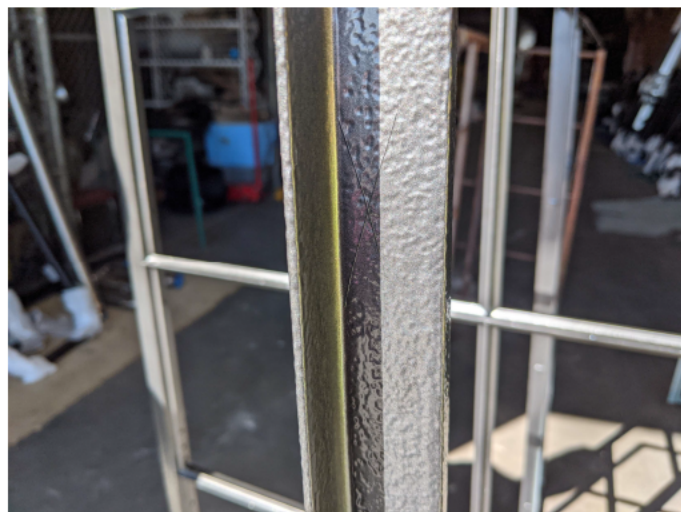
- Surface prep., zinc-rich primer application, powder coating base and topcoat
- Check narrow joints and hardware
- Review texture and thickness, number of passes
- Perform adhesion testing (by means of tape test) per ASTM D3359

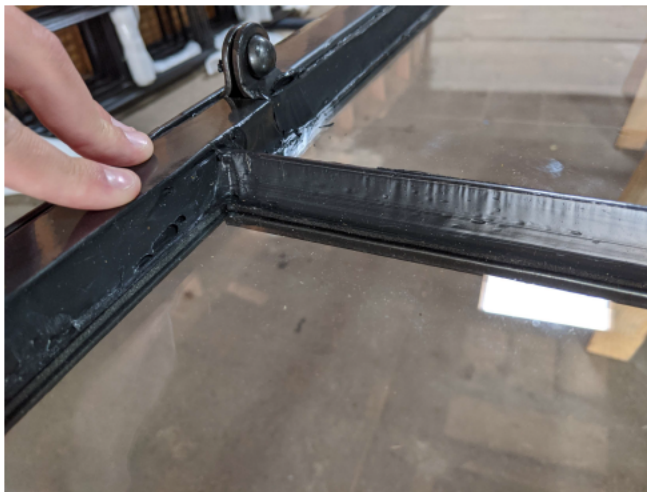
- Review re-glazing strategy and consistency of glazing tape
 - Glazing tape correct cut to fit frame, sealed at intersection
 - Width dimension for sealant bite and tooling (awkward geometry!)
 - Glazing tape and sealant manufacturer to test adhesion to powder coating and glass
 - Field pull test to verify adhesion

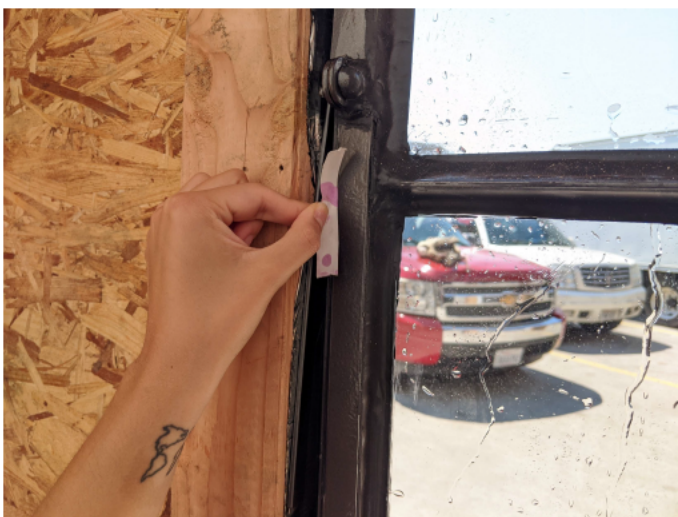
- Review operable vents and gasket strategy
 - Continuity of gaskets - pivot vent unique challenge for sealing center hinge
 - Mock-up and water test first-in-place

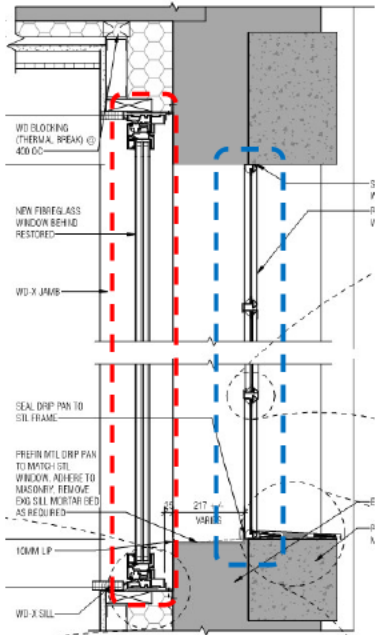
Interior
New triple-pane fiberglass framed windows

- Open-in for cleaning
- Air-sealed
- Set within new interior insulation
- Frames not visible from exterior

Exterior
Original Steel Windows:
Clean, repair, paint, replace glass where needed

Old windows are mostly aesthetic, not providing much thermal or air control benefit

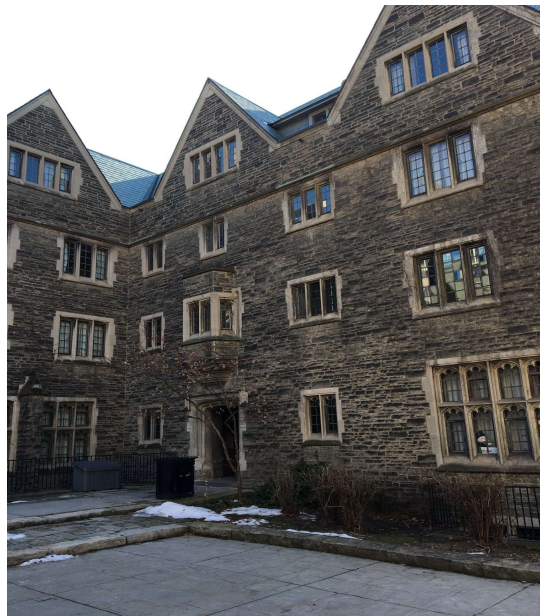
- Steel frames and sash
- Single pane glass
- Some operable, some fixed
- Most fixed lites do not have steel frames – glass is set into stone using lead caming

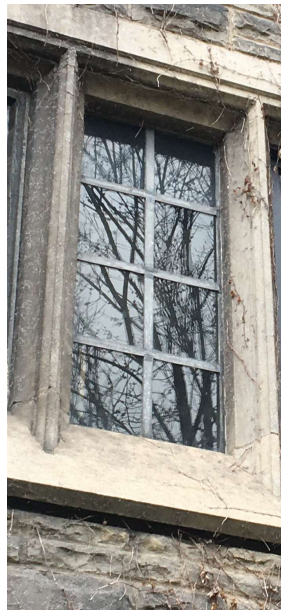
No steel frame

Lead coming set into stone

Lead coming divides the lites

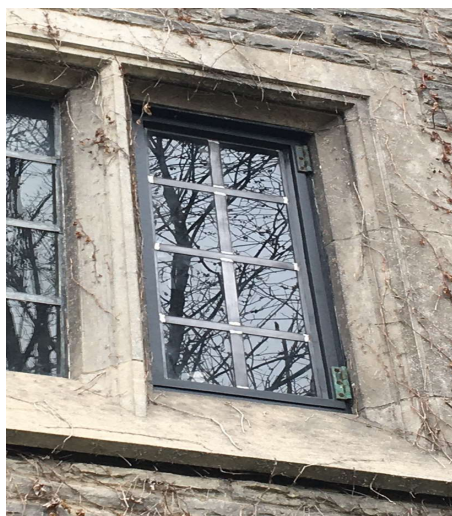
Casement operable vent

Steel frame secured to stone

No insulation or thermal break
on frame

Lead coming divides the lites
within the steel sash

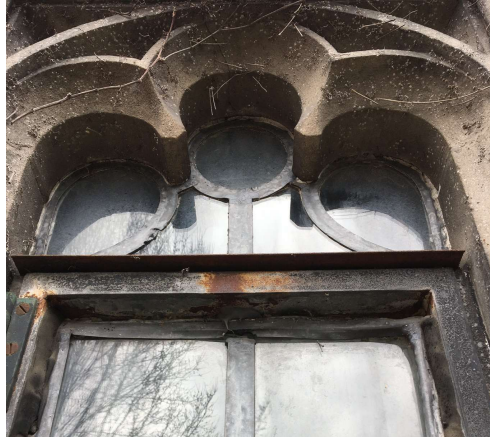
No steel frame

Glass set into stone with
lead cames

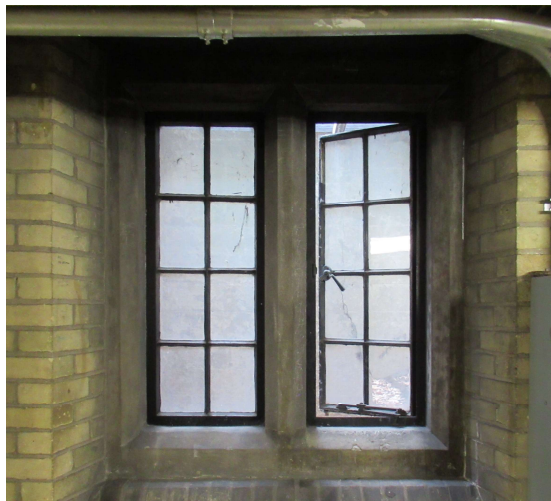
Steel framed fixed and operable

Steel muntins (no lead cames)

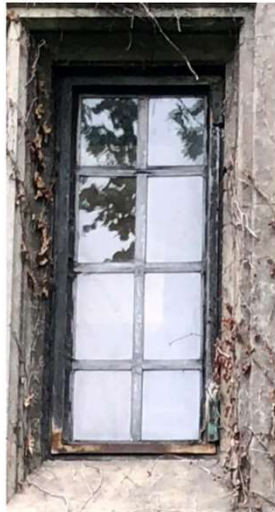
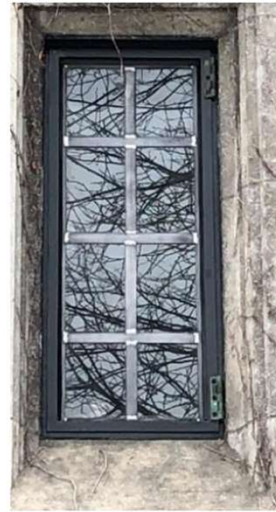
Option 1: Restoration of Existing Frame, Sash, and Single Pane Glazing.

Pros: Preserves the character-defining elements and restores structural integrity.

Cons: Does not address air infiltration, lead canning remains susceptible to damage, and steel frames and sashes may require repair in the near future.

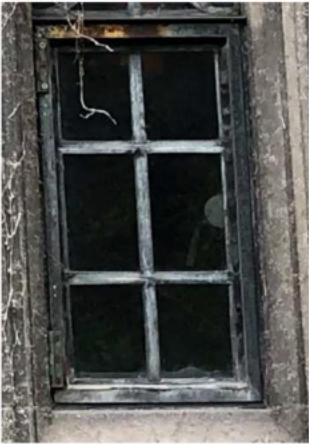
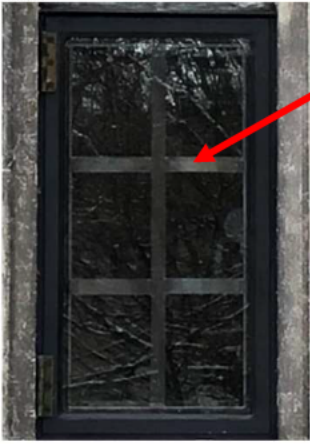
Option 2: Partial Restoration of Existing Frame and Sash, and Replace Single Pane Glazing (Operable Section Only) with Insulated Glazing Unit (Style 1).

Pros: Improves the structural integrity of the sash and addresses air infiltration.

Cons: Steel frames and sashes may require repair in the near future.

New double-pane IGU with lead matrix between glass panes

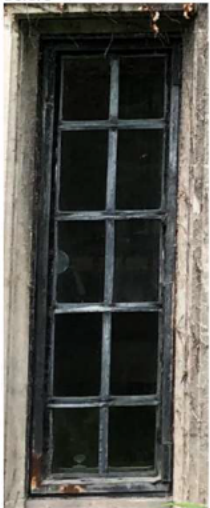
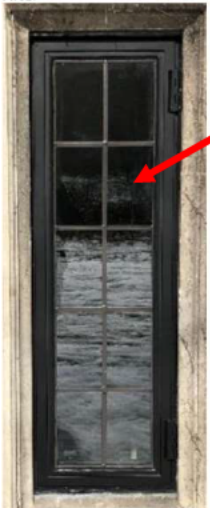
Option 3: Full Unit Replacement including Insulated Glazing Unit (Style 2).

Pros: Retains some character-defining elements, addresses air infiltration, and sash and frames will have the longest expected useful life.

Cons: Lead canning remains susceptible to damage.

New double-pane IGU with lead tape applied to exterior and interior surfaces

New lead tape is thinner than the original comes

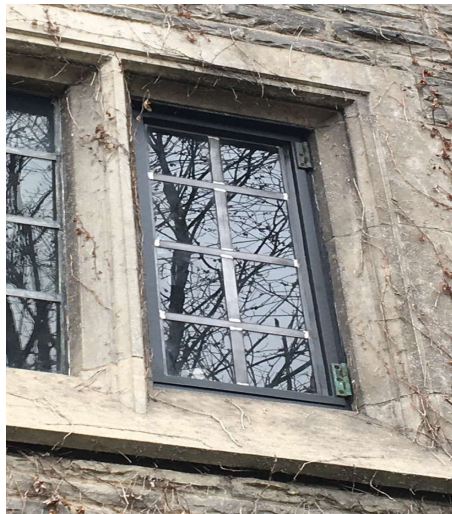
New steel framed windows

IGUs with lead tape on #1 and #2
glass surfaces

Very close match to original

No interior lead coming

Weatherstripping around vent

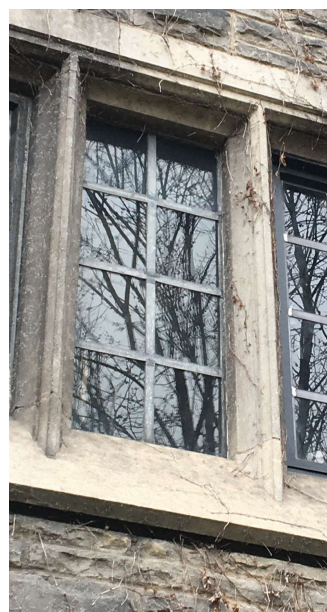
New steel framed windows

IGUs with lead tape on #1 and #2
glass surfaces

*Daylight opening will be slightly
reduced by new steel frame -
New fixed frames will match
operable windows*

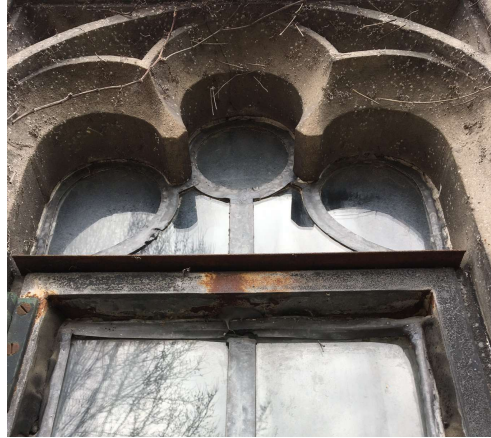
Preservation

New glass set in lead cames

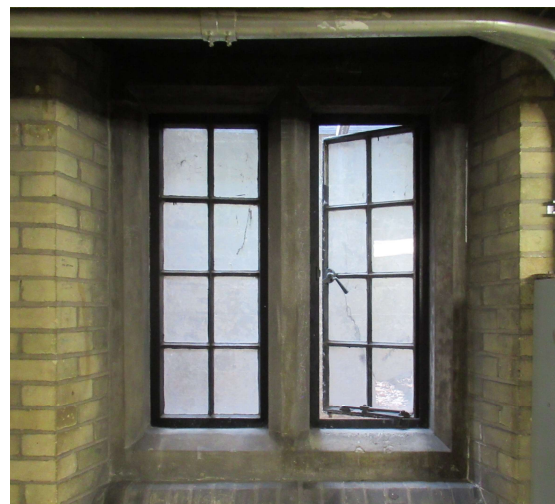
Preservation

Repaint frames and sash
New single-pane glass
Repair/replace hardware to match
