CONDENSATION AND INDOOR AIR QUALITY PROBLEMS AS A RESULT OF HIGH PERFORMANCE BUILDING ENCLOSURES - THE NEED FOR INTEGRATED DESIGN AND A NEW INVESTIGATION PROTOCOL

Brian Hubbs, P.Eng.
Robert Orłowski, ASCT
Graham Finch, P.Eng
RDH Building Engineering Limited

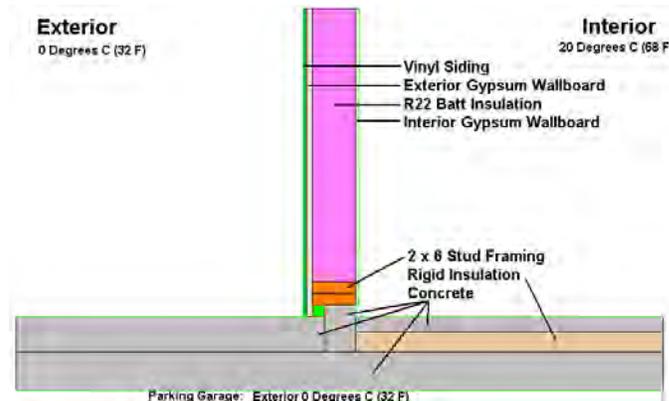
Figure 11
Detail at Base of Perimeter Wall

A simulation of the base of wall detail was performed using Therm 5.2 [3] to better understand the contribution of the thermal bridging to the condensation and mold problem. The model utilized an exterior temperature of 0°C and an interior temperature of 20°C. At this temperature and an interior relative humidity of 50% the dew point of the air is 9°C. The simulation in Figure 12 models the wall interface without interior furniture. The coldest interior temperature is 12.5°C indicating that the risk of condensation would be quite low under the modeled conditions. When the same detail was modeled with a sofa on the interior of the wall in Figure 13, the results show surface temperatures of 6.7 °C, which is significantly below the dew point of the modeled conditions. The temperature region between 6.7°C and 9°C (dewpoint), shown on Figure 12 is approximately the same location where interior mould was observed on the walls during the investigation.

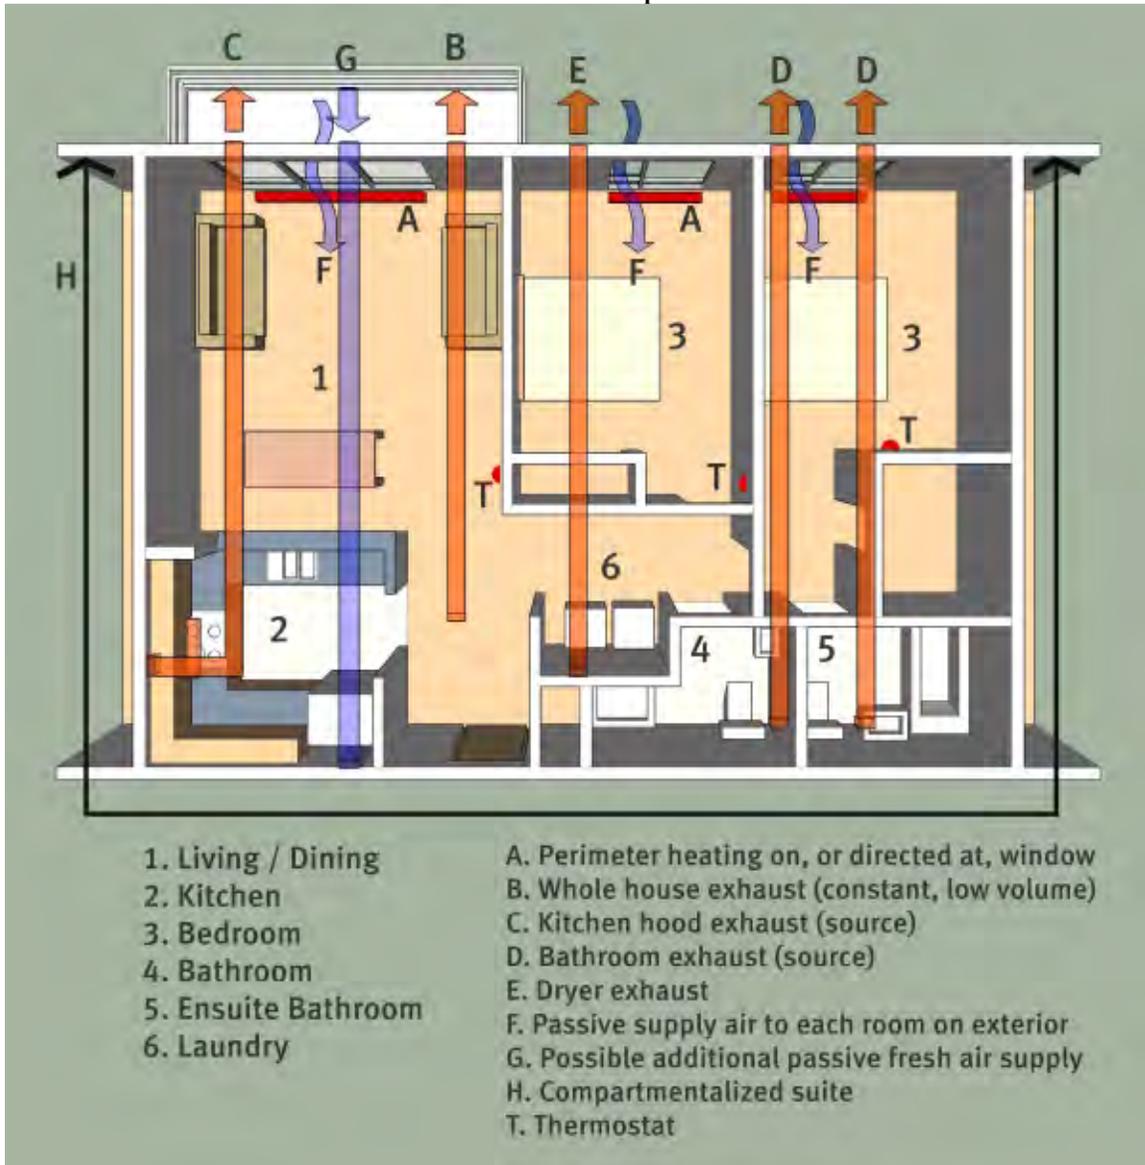
Figure 15
Conceptual HVAC strategy for multi-unit residential building that facilitates effective control of interior environmental conditions as well as temperatures at exterior walls.

Figure 15 provides a conceptual illustration of the recommendations for an arbitrary suite in a multi-unit residential building.
