RESEARCH REPORT

October 2, 2001

STUDY OF HIGH-RISE ENVELOPE PERFORMANCE IN THE COASTAL CLIMATE OF BRITISH COLUMBIA

RDH Building Engineering Limited

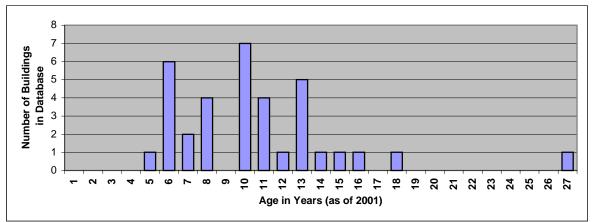
FIGURE 3.1 AGE PROFILE OF BUILDINGS

Figure 3.1 shows the age distribution of the buildings included in the study. There is one building included in the study group whose age falls outside the specified eligibility range; however this building was included because it is constructed with a "drained cavity" wall assembly (relatively unique for its time), and has performed adequately for more than 20 years in the Lower Mainland climate.

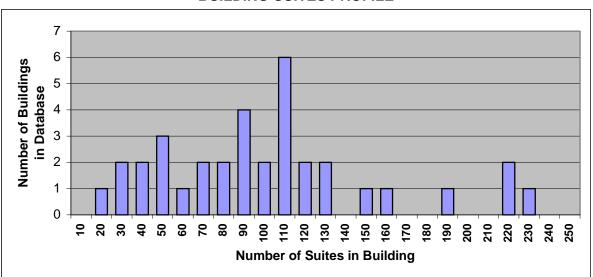
FIGURE 3.2 BUILDING SUITES PROFILE

Figure 3.2 presents the distribution of study group buildings with respect to the number of suites, a good indicator of the size of the building. The average "problem" building in the study group has 91 suites, while the 4 no-problem buildings have an average of 135 suites. There is a weak correlation between the age of study group buildings and the number of suites in them, indicating a trend for newer buildings in the study group to contain more suites.

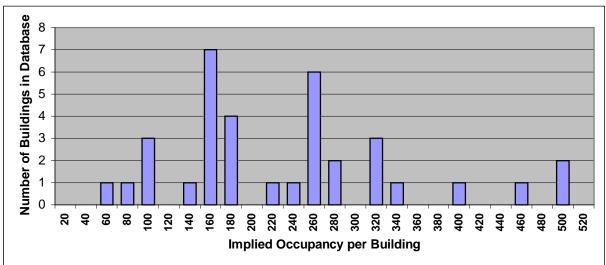
FIGURE 3.3 BUILDING IMPLIED OCCUPANCY PROFILE

Figure 3.3 shows the distribution of "implied occupancy" in the study group buildings. The implied occupancy has been calculated using the following assumptions:

The average occupancy load of the "problem" buildings is 207, for an average suite occupancy of 2.28 persons. The average occupancy load for the "no-problem" buildings is 329, for an average suite occupancy of 2.44 persons. Three of the five largest-occupancy buildings are in the "no-problem" category.

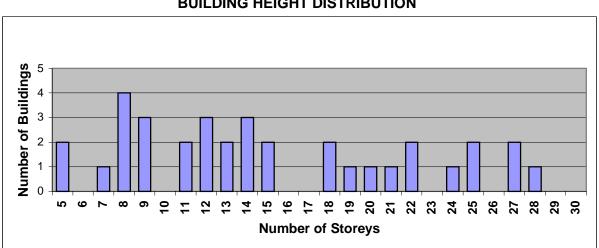
FIGURE 3.4 BUILDING HEIGHT DISTRIBUTION

Figure 3.4 presents the distribution of building height in the study group buildings. The average building is 15 storeys in height; the 4 "no-problem" buildings average 22 storeys high.

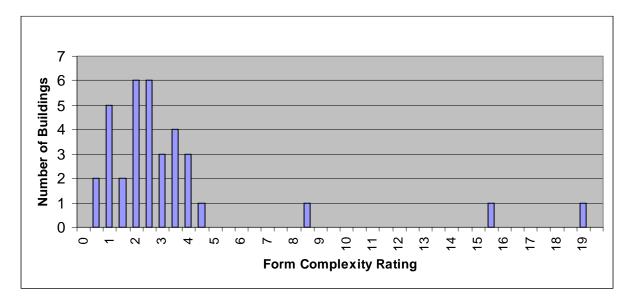
FIGURE 3.5 BUILDING FORM COMPLEXITY RATING DISTRIBUTION

Figure 3.5 shows the distribution of "Building Form Complexity Rating" among the study group buildings.

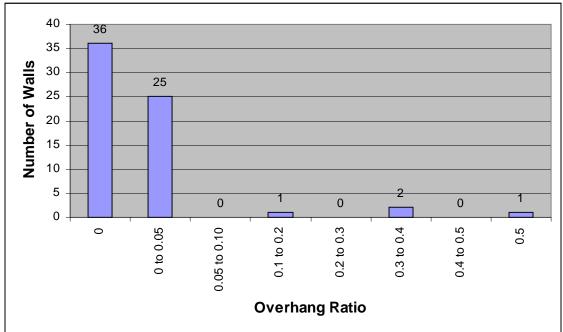
FIGURE 3.6 DISTRIBUTION OF WALL OVERHANG RATIOS

Figure 3.6 shows the distribution of overhang ratio for walls in the database. About 2/3 of the walls defined have no overhang at all. Only 4 walls have an overhang ratio greater than 0.1 (equivalent to 250mm (10") per storey of height); all of these walls are one storey or less in height, and none were damaged.

No relationship was found between the overhang ratio and the percentage of walls that were damaged by moisture exposure. Five of the 35 main wall assemblies (making up most or all of the height of the building) were not damaged; 3 of these walls had no overhang and the other two had very small overhang ratios, equivalent to an accent reveal band at the top of the wall.

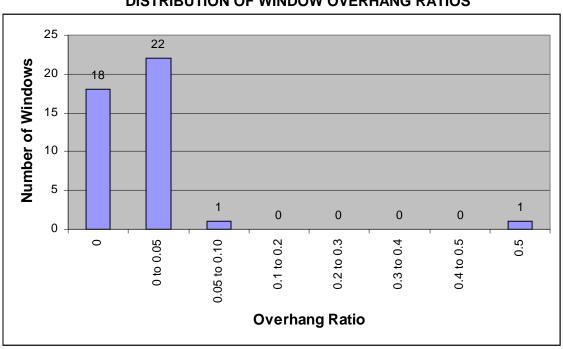
FIGURE 3.7 DISTRIBUTION OF WINDOW OVERHANG RATIOS

Figure 3.7 shows the distribution of window overhang ratio for the 42 window assemblies in the database. Typically, only one or two different types of window assembly are used on these buildings. 25 of the 42 window assemblies are essentially flush with the exterior wall face and have no overhang. The remaining 17 assemblies have small overhangs, some of which represent windows rebated within the surrounding wall assemblies, and some of which are protected by the overhangs within the wall above. No relationship was found between the overhang ratio and the percentage of windows that were damaged by moisture exposure.

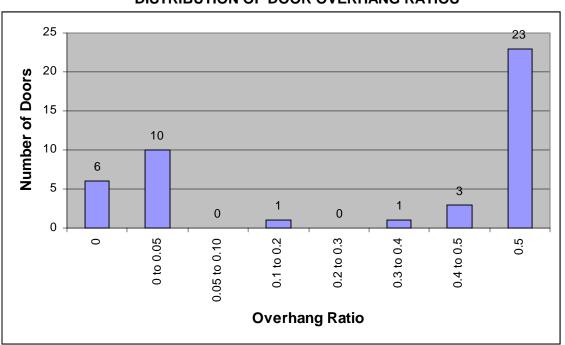
FIGURE 3.8 DISTRIBUTION OF DOOR OVERHANG RATIOS

Figure 3.8 shows the distribution of door overhang ratio for the 44 door assemblies in the database. The overhangs on doors are typically large as a result of balconies being located in vertical stacks so that the balcony above shelters the door to the balcony below. More than half of the buildings provide this protection even to doors located on the top floor, which don't have a balcony above.

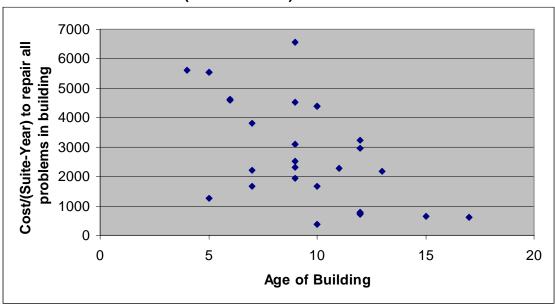
FIGURE 3.9 COST/(SUITE x YEAR) VS. AGE OF BUILDING

Regression analysis was carried out in order to determine the importance of variables such as building size and age on the cost of repairs as a result of envelope failures on the high-rise buildings in the study group. Figure 3.9 shows the relationship of Repair Cost/(Suite x Years) to the age of the building. The cost statistic represents the amount of money that each suite owner would have had to put aside each year since the suite was new, in order to pay for the repairs that were required to deal with all envelope problems in the building. The logarithmic correlation of this statistic to the age of the building was over 60%, representing a moderate level of explanation (60% of the variation in cost is explained by the variation in age of the buildings). Since the cost statistic is already normalized for the age of the building, it appears that factors such as different cladding systems and different building heights used on newer buildings also play a role in making the cost greater for newer buildings.

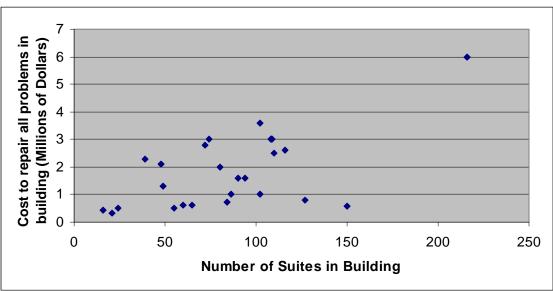
FIGURE 3.10 COST VS. NUMBER OF SUITES

Figure 3.10 is a scatter chart showing the relationship between cost of repairs and size of building. As expected, a moderately good correlation coefficient over 0.70 was found for the linear relationship of these variables. The total cost of repairs is closely related to the size of the building.

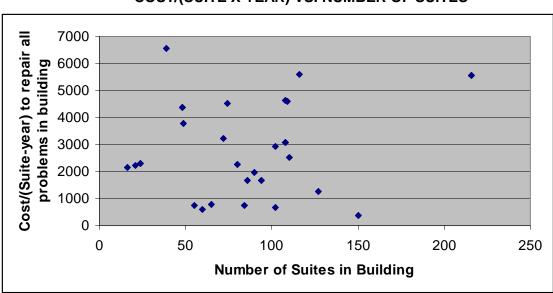
FIGURE 3.11 COST/(SUITE X YEAR) VS. NUMBER OF SUITES

The relationship between cost/(suite x year) and the number of suites in the building shown in Figure 3.11 is quite poor, with a correlation coefficient of 0.23 for a linear relationship. Thus, the cost/(suite x year) has little relationship to the size of the building – a suite in a small building costs about as much to repair as one in a large building.

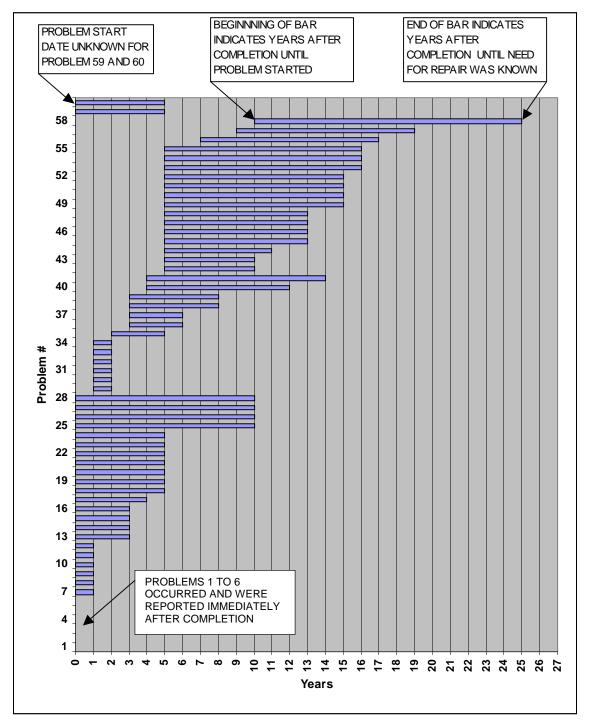
FIGURE 3.12 TIME TO PROBLEM OCCURRENCE AND REPORTING

Figure 3.12 shows the distribution of "Time to Start" and "Time to Report" for the 60 problem reports in the database. Time to Start indicates when the damage resulting in the need to repair started, whereas Time to Report indicates when the owners generally became aware that repairs would be required (not when the first symptoms of damage were reported). Note that nearly half of the problems were considered to be inherent design or construction defects that were allowing water ingress since the time of the original construction of the building. In the majority of cases, there is a time lag of a few years before a problem relating to water ingress through the envelope assemblies is reported. This indicates that assessments of envelope performance issues during the years immediately after construction are failing to identify the problems. This may be due to:

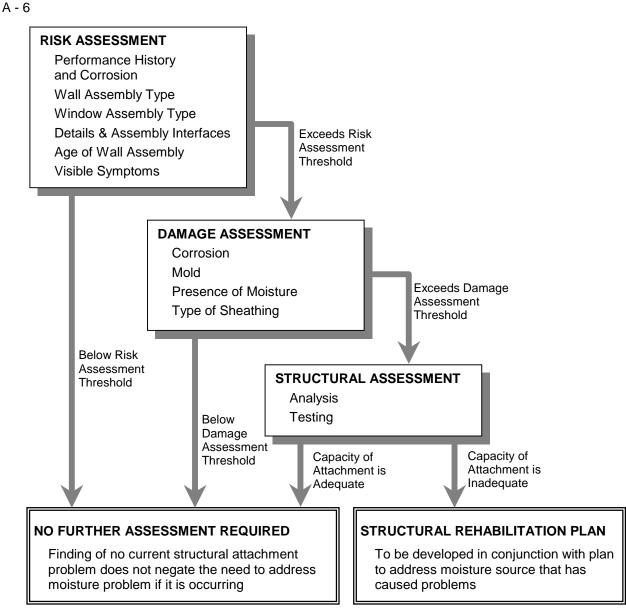
Figure A-1: Assessment of Structural Attachment of Cladding Process

Figure A-1 illustrates the three stages of the assessment of structural attachment process. The following sections describe each of these stages of assessment in more detail.

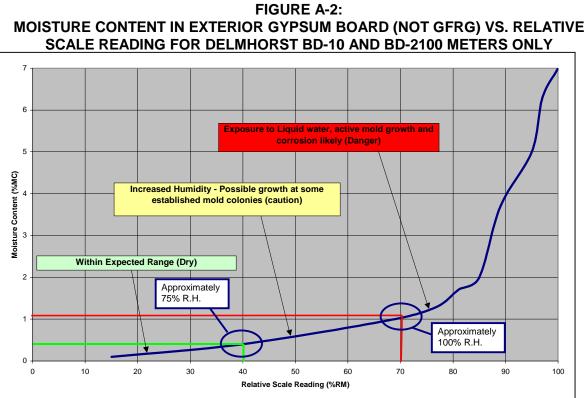
The use of moisture metres in gypsum board products requires knowledge of the specific material properties as well as the specific calibration curves for the instrument used to obtain measurements. Figure A-2 illustrates the relationship between the relative moisture scale on the metre and moisture content of exterior gypsum board. Unfortunately unlike wood moisture content thresholds, the moisture content for mold to initiate, support mold growth and to cause softening and non recoverable damage to the paper facing or gypsum core are not well established. Due to the composite nature of the material it is difficult to establish these relationships for gypsum sheathing products. The threshold numbers shown in Figure A-2 reflect conservative ranges based on the minimal information that is currently available. The thresholds are linked to mold growth since it is the paper facing that acts as a food source for the mold, and the paper on the sheathing is generally considered to be the weak link in the composite behaviour of gypsum sheathing.
