2014 ASHRAE TECHNOLOGY AWARD CASE STUDIES

HONORABLE MENTION
RESIDENTIAL, NEW

Affordable And Efficient

Ramona Apartments

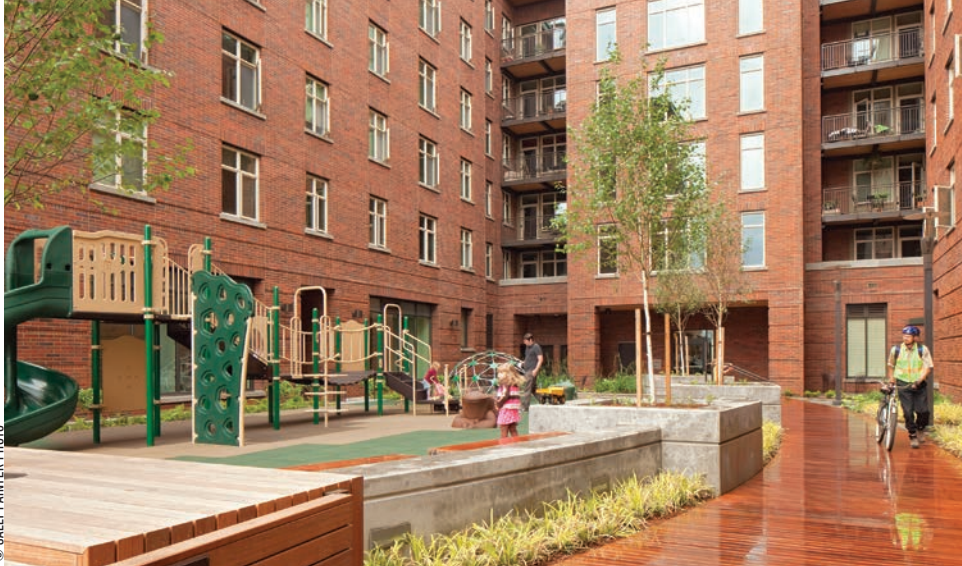
LEFT The courtyard sits above an underground parking garage, but is designed with a drainage system that filters all of the stormwater before it drains to the municipal storm sewer.

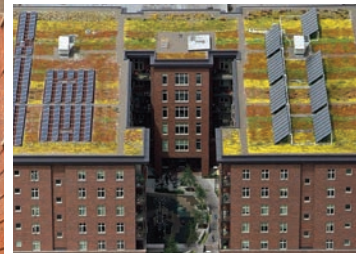
ABOVE At 31,597 ft², this was the largest contiguous ecoroof in Portland in 2011. The roof is planted with drought-tolerant native species, has PV panels on the south half and solar water heaters on the north half.

- **Solar hot water.** An array of 64 panels (4 ft x 10 ft [1.2 m x 3 m]) on the north half of the roof supplies about 50% of the hot water heating.
- **Photovoltaic panels.** A 29.92 kW PV system is installed on the south half of the roof. Actual production over three years has averaged 34,195 kWh per year, approximately 8% more than forecast.

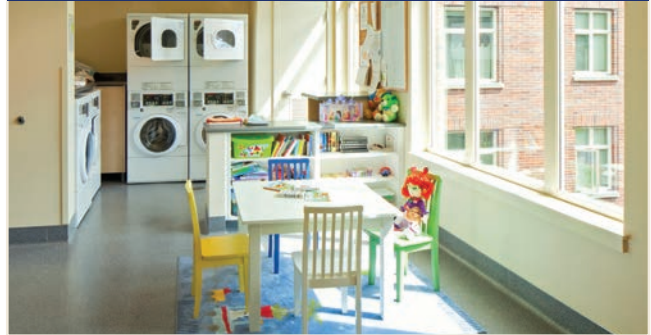
Large common laundry rooms on each floor have high-efficiency equipment. The front loading machines have lower costs for cold-water washes.

Kitchen appliances in the apartments are Energy Star rated. Common area laundry rooms on each floor have high-efficiency front-loading washing machines and gas dryers with higher prices for warm and hot water modes. A separate MEP engineer was used to provide commissioning services that included:
